## A Preliminary Study of the 16 June 2014 Tornadoes in Northeast Nebraska

## Brian E. Smith and Daniel Nietfeld – NOAA/NWS Omaha/Valley, NE

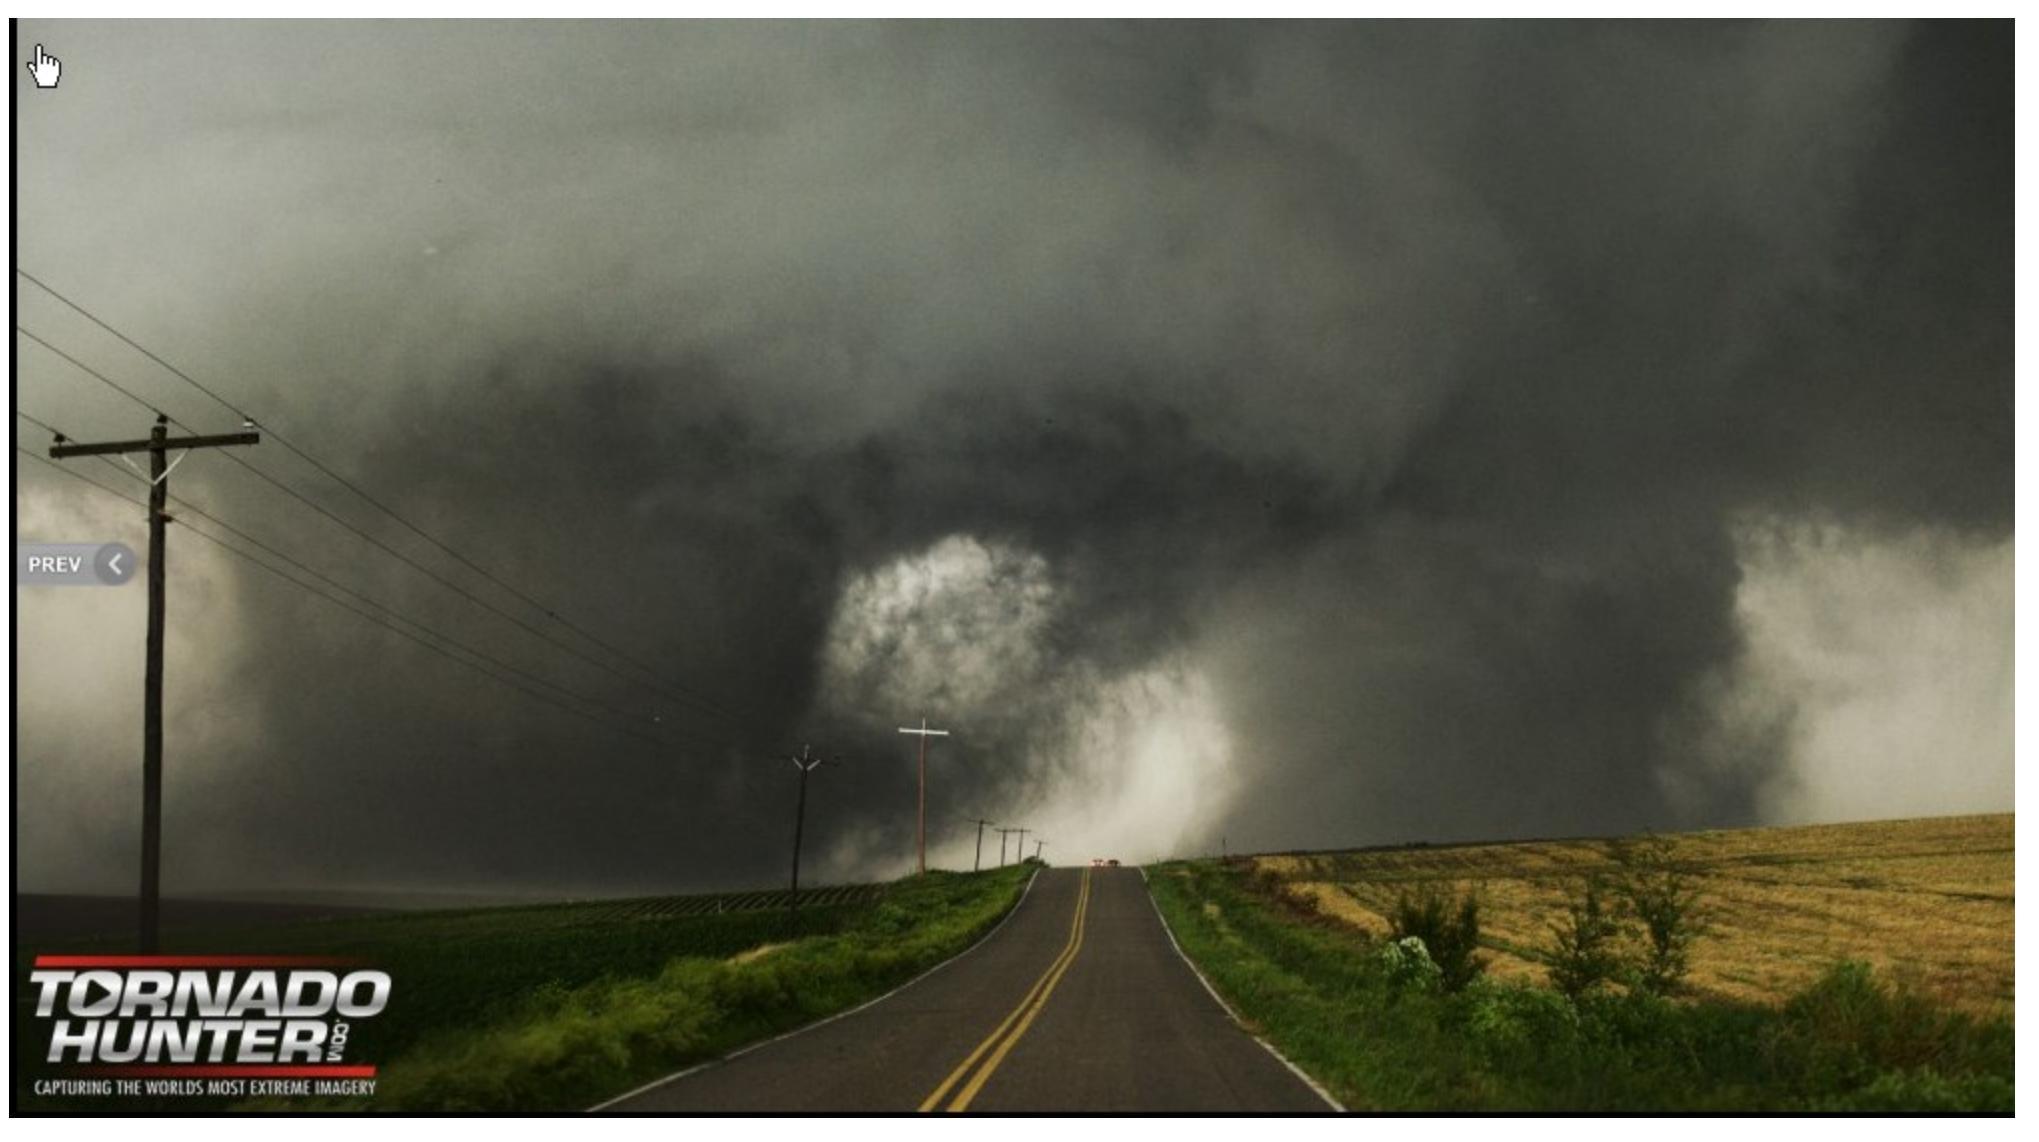
Two tornadoes looking north on a county road northwest of Wisner, NE.. The tornado on the left is the one that struck the town of Pilger. The tornado on the right is one that developed southeast of Pilger and moved northnortheast. . Photo courtesy of Greg Johnson..

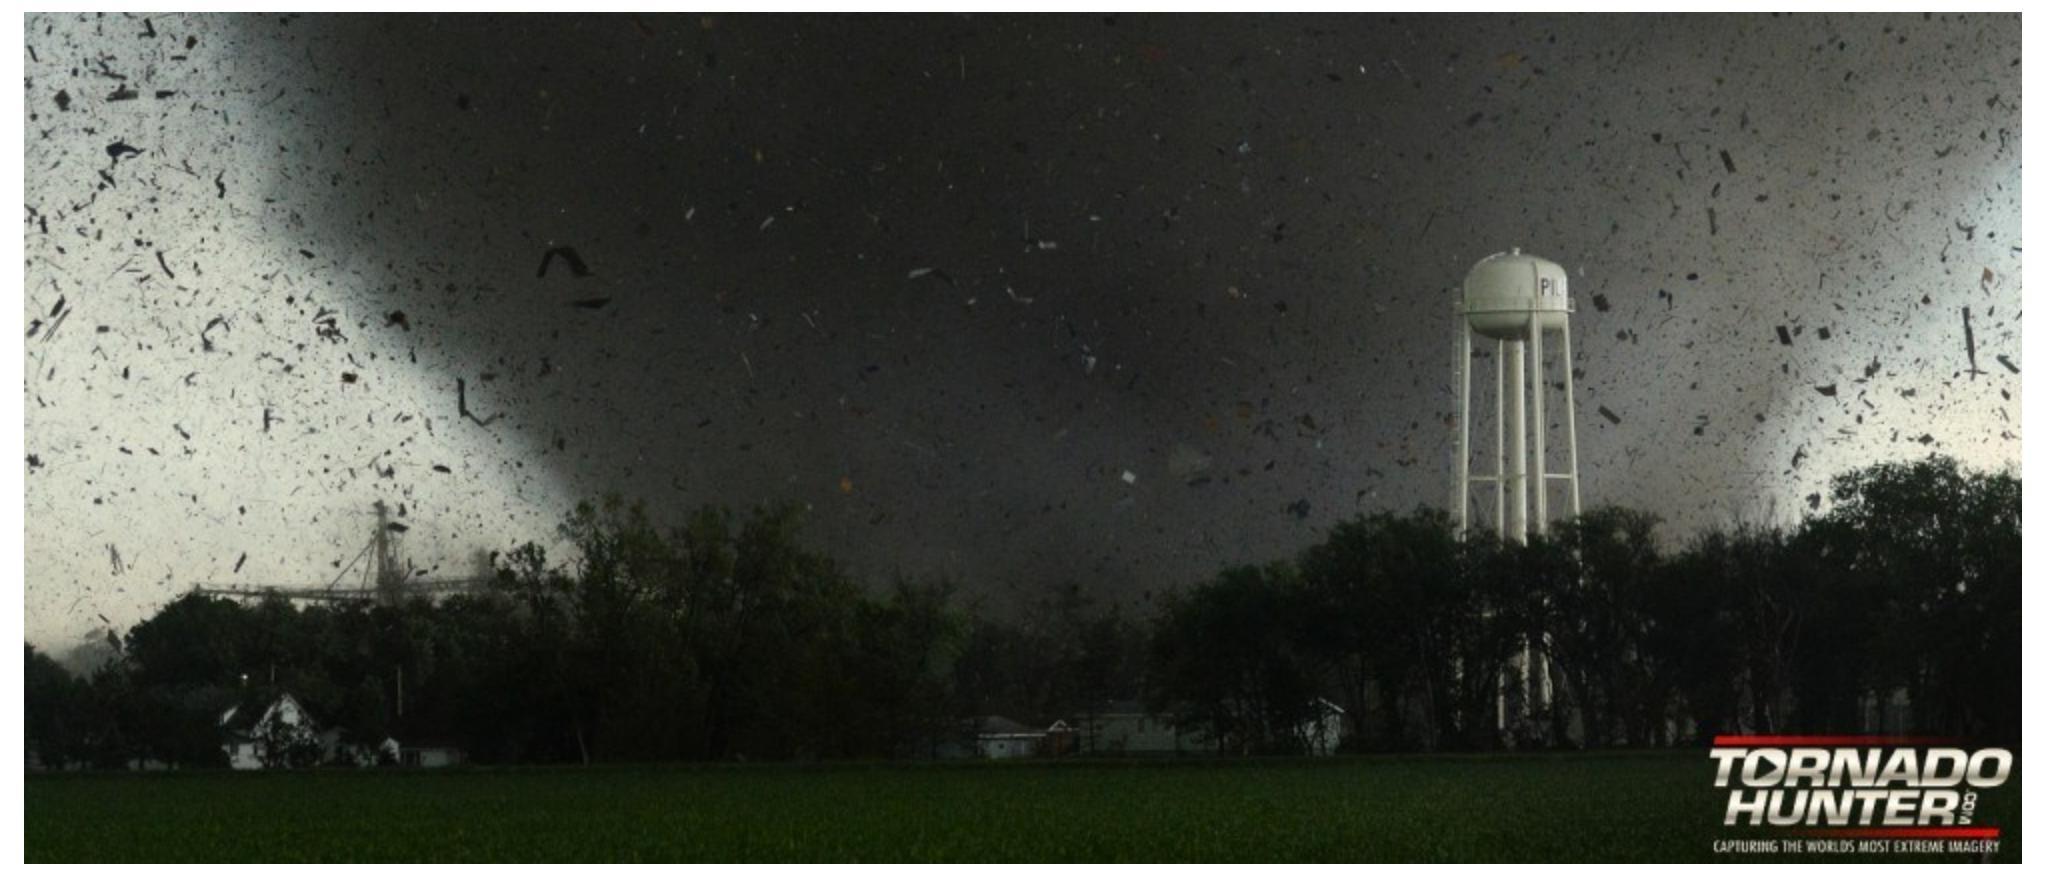
Debris loaded tornado as it passes through downtown Pilger, NE. Photo courtesy of Greg Johnson.

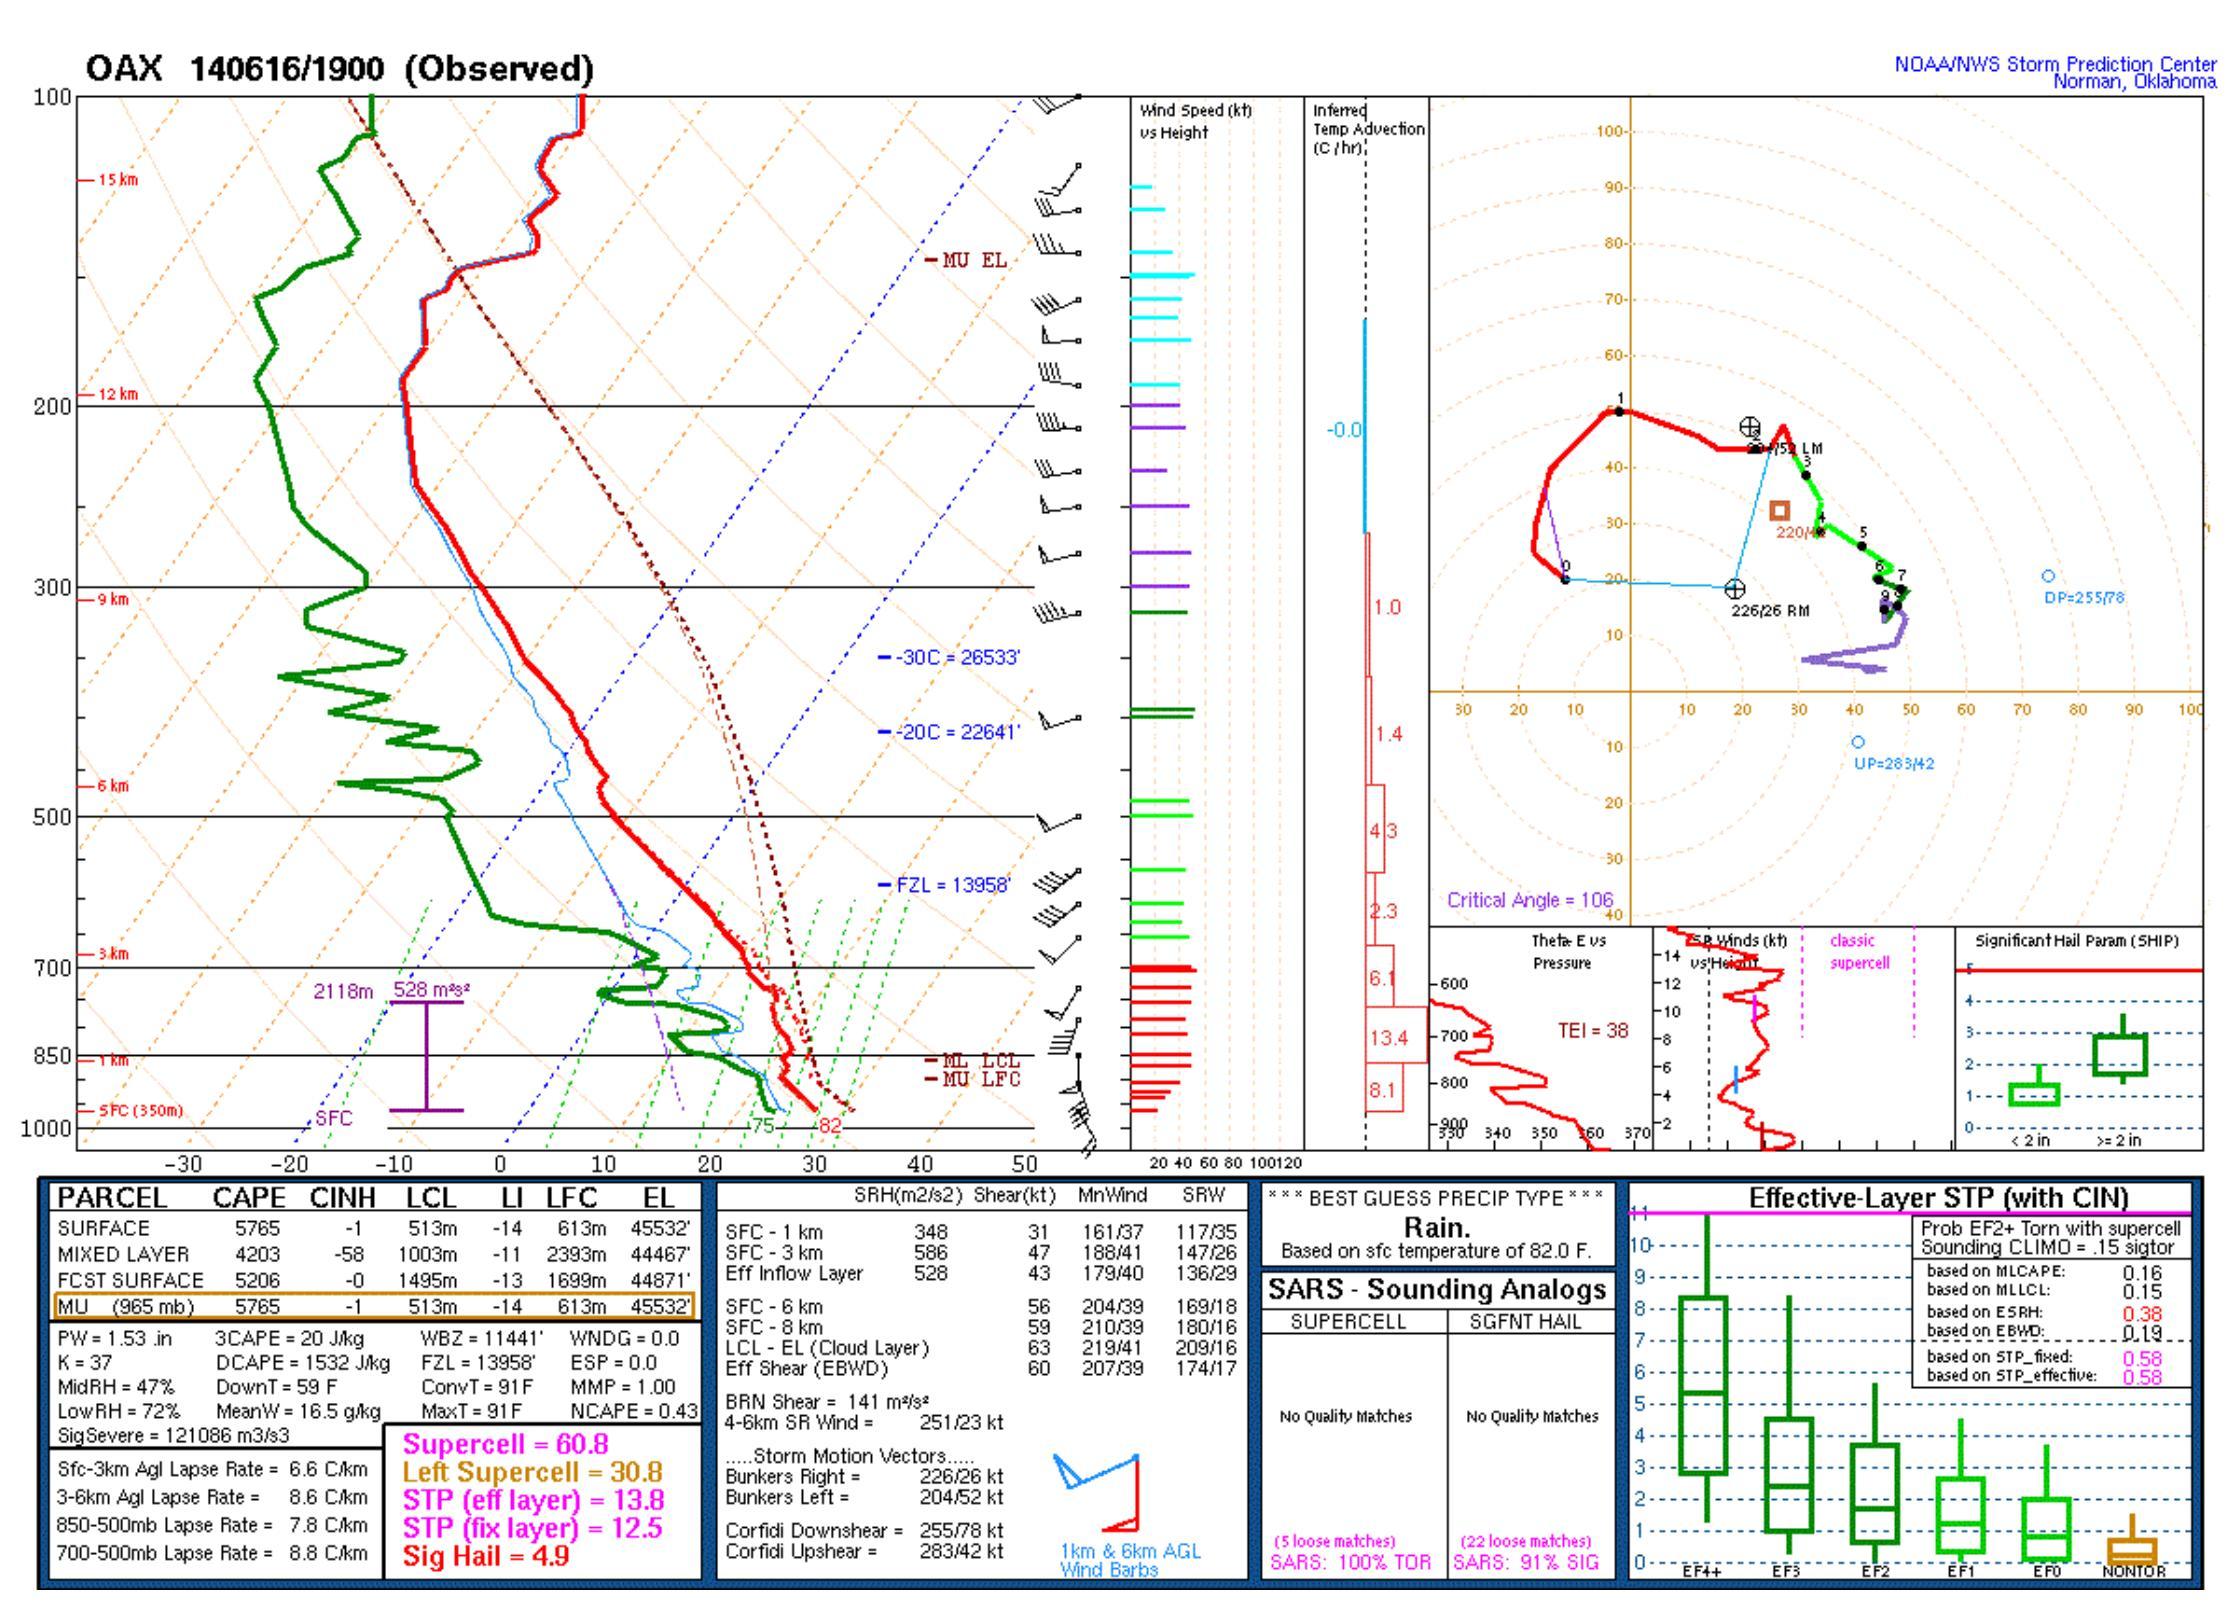
Impressive Skew-T from the 19Z upper air launch at the Valley WFO. Mixed layer CAPE was 4203 J Kg-1 and the surface to one kilometer storm relative helicity was 348 m2 s-2.

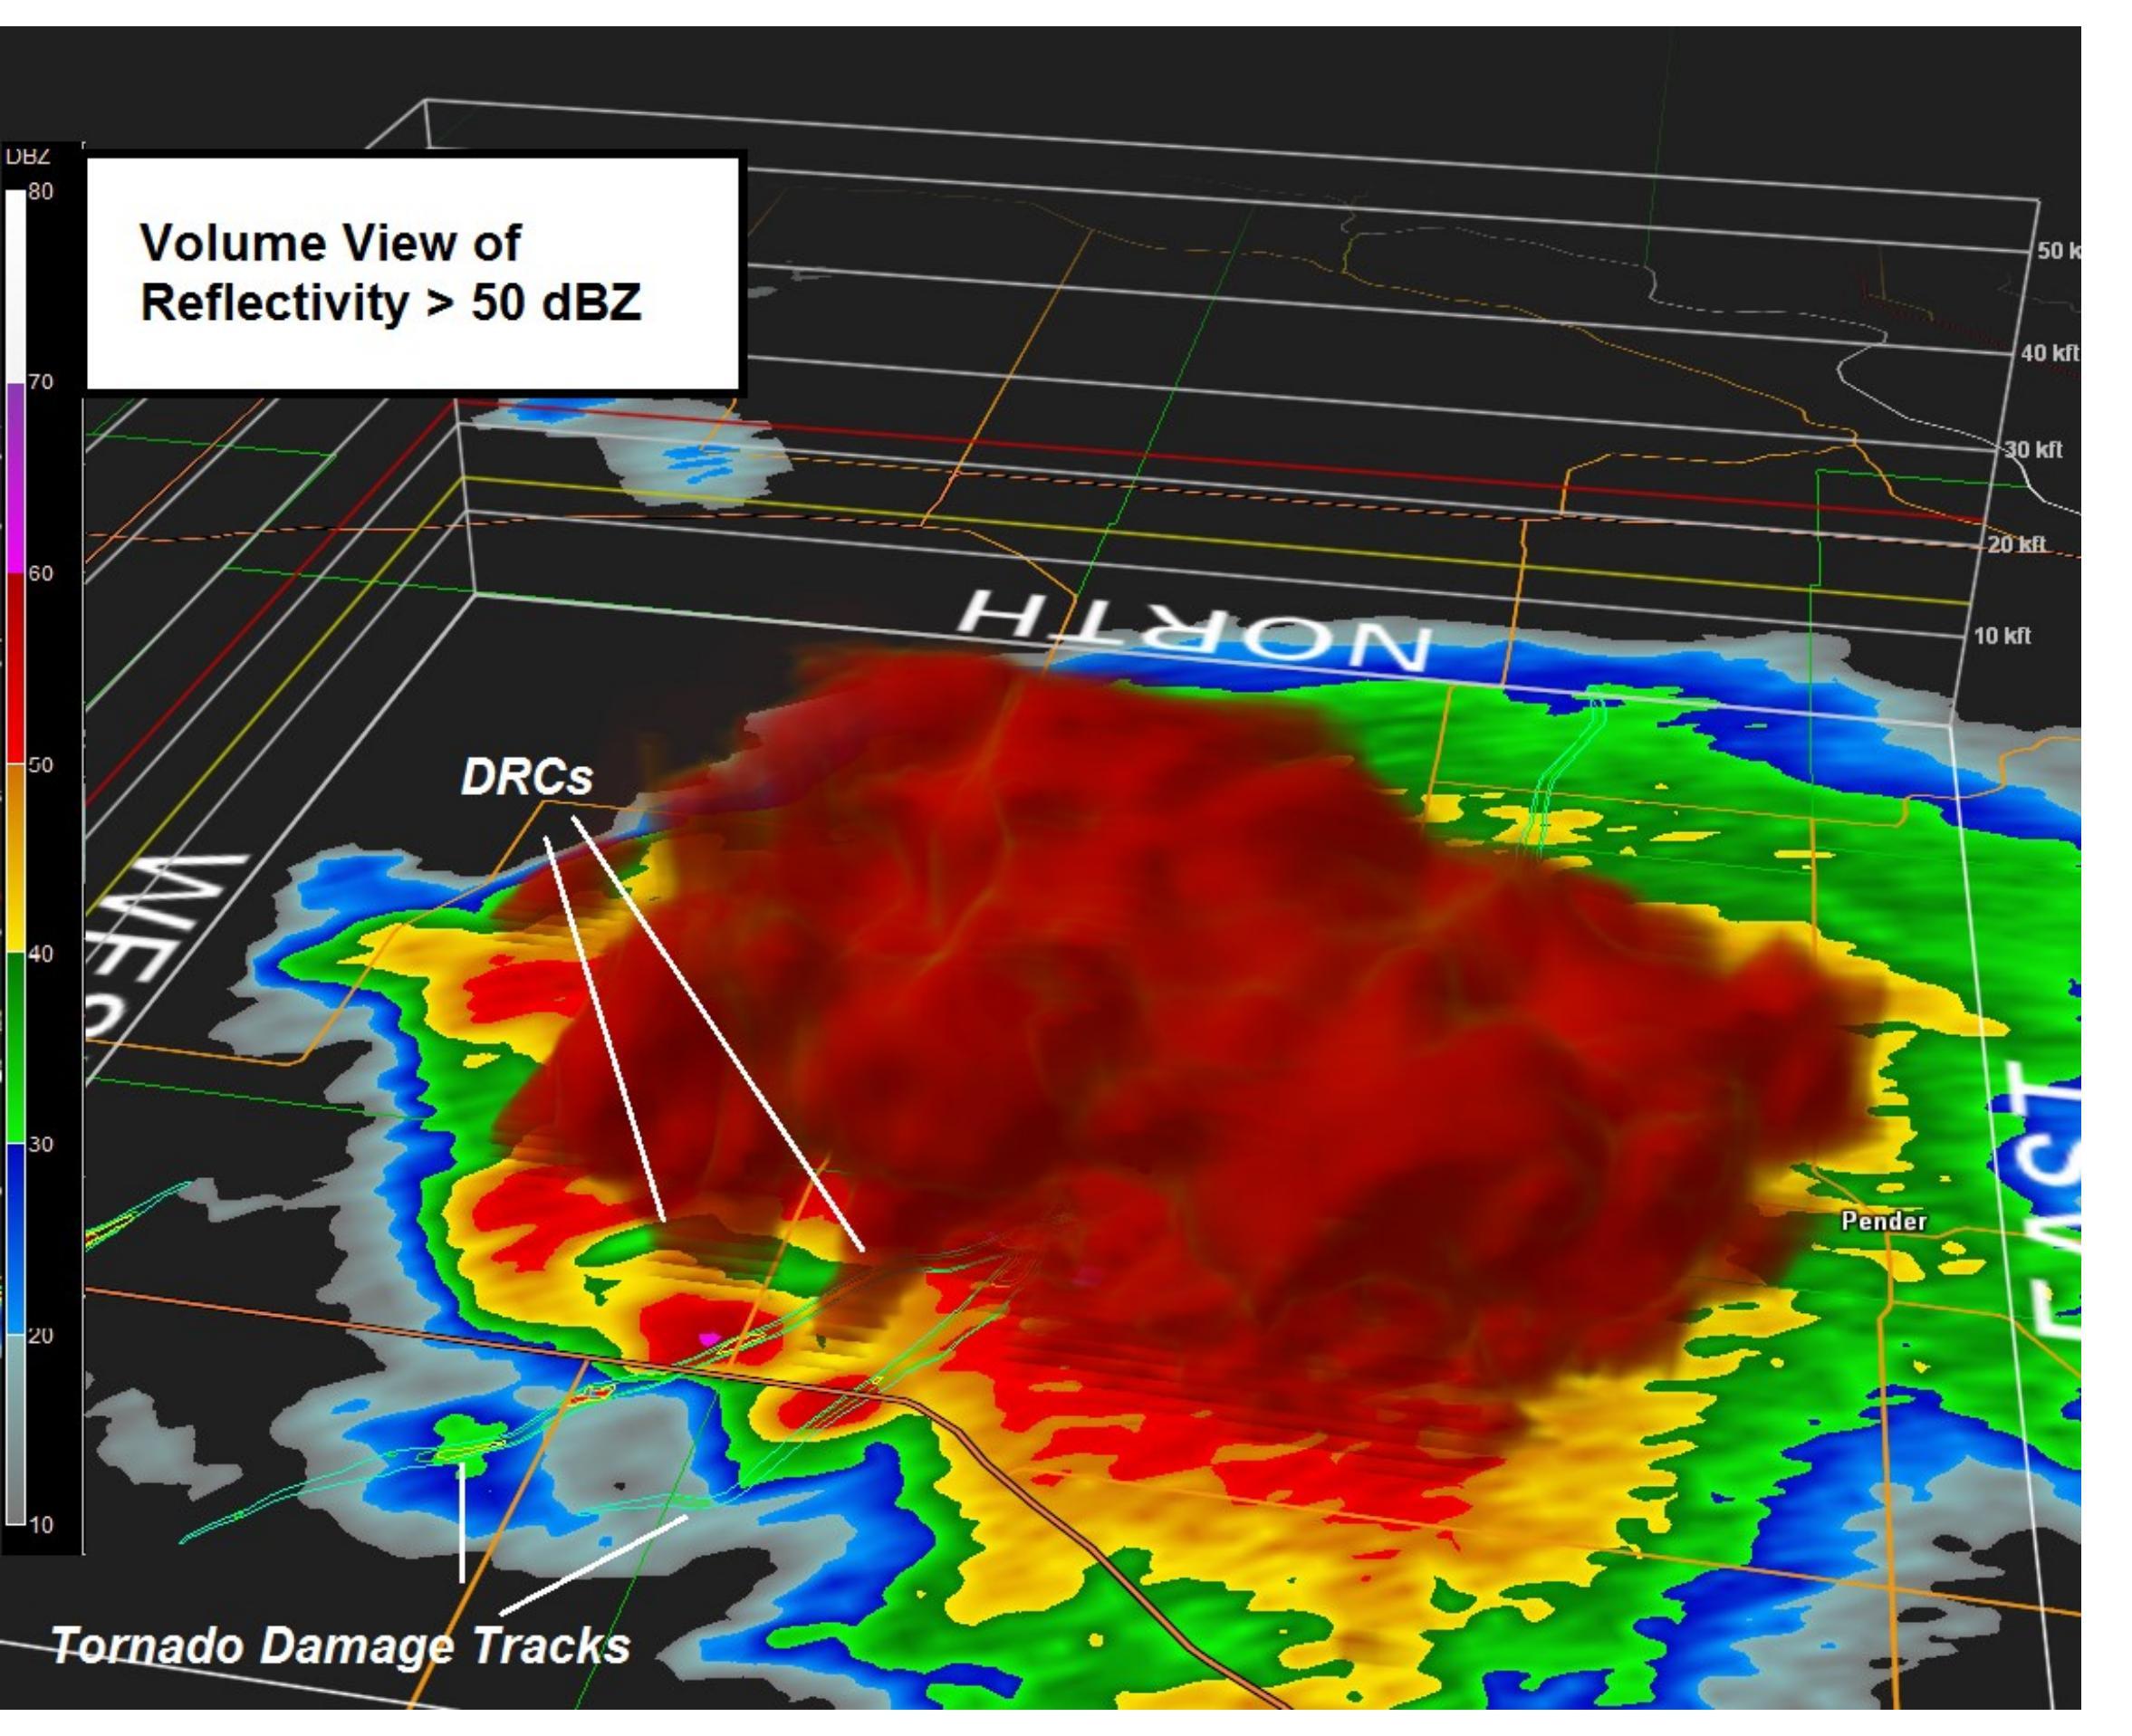
Gibson-Ridge Lit volume view of the Pilger storm at 2121Z. The Descending Reflectivity Cores (DRC) associated with each tornado is indicated in this image. It is suspected that the Rear Flank downdrafts were very buoyant as there were was a lack of RFD damage and no storm chaser accounts of intense
