Timothy P. Marshall<sup>1</sup>, John Robinson<sup>2</sup>, Ernst Kiesling<sup>3</sup> and Larry Tanner<sup>3</sup>

<sup>1</sup>Haag Engineering Company, Irving, Texas

## 1. INTRODUCTION

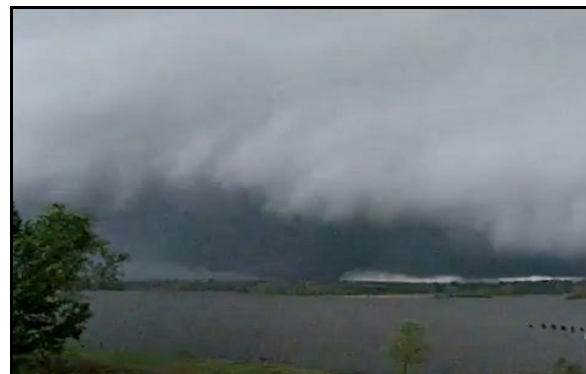
The tornado then crossed Lake Maumelle, a man-made lake that serves as the primary drinking water supply for Little Rock. The tornado remained relatively weak, causing only EF0 to EF1 damage to trees on the north shore of the lake. After crossing Highway 300, the tornado traveled through bottom land east of the community of Roland. Eyewitnesses reported the tornado grew to a wedge-shape as it crossed the Arkansas River (Fig. 6). The tornado was visible at this stage although hills and trees obstructed visibility.

**Figure 6.** Large tornado as it approached the Arkansas River. Image from KATV video.

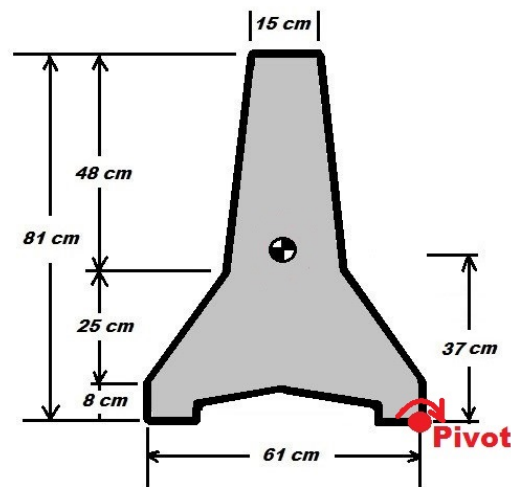
Just as the tornado was leaving the River Plantation subdivision, it toppled seven concrete highway barriers near the approach to a bridge (Fig. 12). The barriers are not listed as a DI, however, they afforded an opportunity to approximate the wind forces necessary to overturn them. Barriers were free-standing, not connected to each other. Each concrete barrier weighed about 1800 kg, was 81 cm tall, and 3 m long. The center of gravity was approximately 37 cm above the ground (Fig. 13). From this information, the resisting moment was calculated, then equated to the moment created by the applied wind pressure, solved for wind pressure, then

computed the failure wind speed. The wind speed necessary to overturn the concrete highway barriers was determined to be approximately 83 m/s (185 mph). However, it was assumed that the wind load was static (which it was not) and that pressure coefficients were known, (which they were not). Pressure coefficients were derived using standard values from buildings (not a barrier) in a wind tunnel (not a tornado). These coefficients were +0.8 front, -0.7 top, and -0.5 back. Also, the computed wind speed was for an instantaneous load (not averaged over three-seconds) and centered on a beam much lower than the 10 m height used for the EF-scale. That said, the highway barriers were adjacent to homes that experienced EF3 and EF4 damage. So, the calculated wind speeds were at least consistent with those estimated for nearby homes.

**Figure 13.** Cross section of a standard concrete highway barrier. Seven of these were toppled in the River Plantation subdivision.

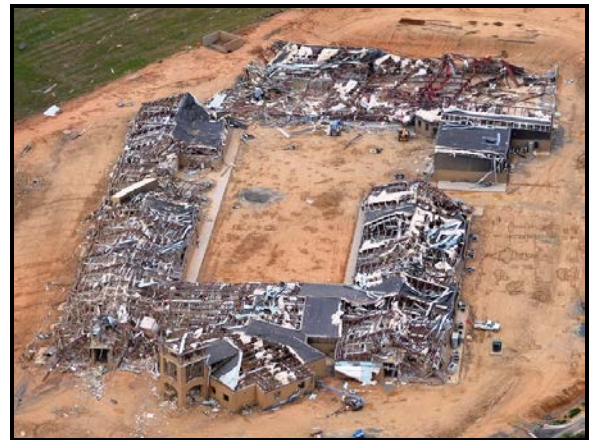
The next community impacted by the tornado was Vilonia. The tornado struck the Intermediate School that was under construction and nearing completion. The school complex consisted of three, steel-framed structures with masonry veneer exterior walls and metal panel roofs (Fig 19). Masonry walls fell inward on windward sides, and outward on leeward sides, exposing the classrooms to wind-borne debris (Fig. 20). Steel purlins and girts buckled. However, most of the large steel frame remained intact except for the west building which had successive frames collapse. Metal roof panels were removed when they became unclipped from steel purlins. Center hallways would have been the only places of relative safety for occupants had school been in session (Fig 21). Overall, damage to the elementary school (ES) building was rated EF3 (DoD 8).

**Figure 19.** Aerial view of the Vilonia Intermediate School.

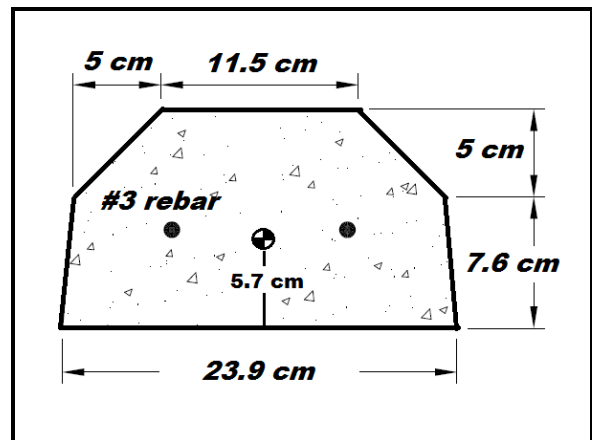
There was a parking lot north of the main church building where several concrete parking stops slid sideways in the tornadic winds (Fig. 26). Parking stops measured 1.9 m long and weighed 111 kg. Each parking stop was 12.6 cm tall and 23.9 cm wide (Fig. 27). There were two vertically-oriented holes in the parking stops for anchoring with rebar. However, no rebar was installed. Thus, the parking stops were lying loose on the pavement surface. Marshall et al. (2012b, 2014) had observed lofting and lateral movement of parking stops in the Joplin and El Reno tornadoes, respectively.

**Figure 27.** Dimensions of the concrete parking stops in the lot north of the church.

The wind speed necessary to slide the parking stops depended on the coefficient of friction (COF). Also, there would also be an uplift component from wind traveling over the top of the parking stop. Assuming wet pavement, the COF is about 0.5. Using the same assumptions as the highway dividers mentioned earlier in this paper, including the same pressure coefficients, the wind speed necessary to slide the concrete parking stops was calculated to be
