P1A.3 Damage survey of the North Texas Tornadoes: 26 December 2015

Timothy P. Marshall¹, Mark Fox², Melissa Huffman³, and Dennis Cavanaugh⁴

¹Haag Engineering Co., ²NOAA/NWS

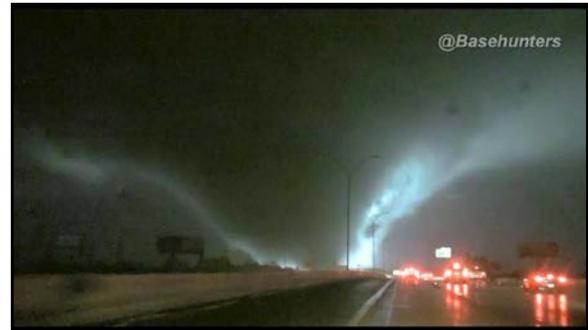
Fig. 1. Tornado crossing Interstate 30 in Garland, Texas illuminated by a power flash. View looks east. Cars were tossed from the highway killing 10 people. Image courtesy of Scott Peake.

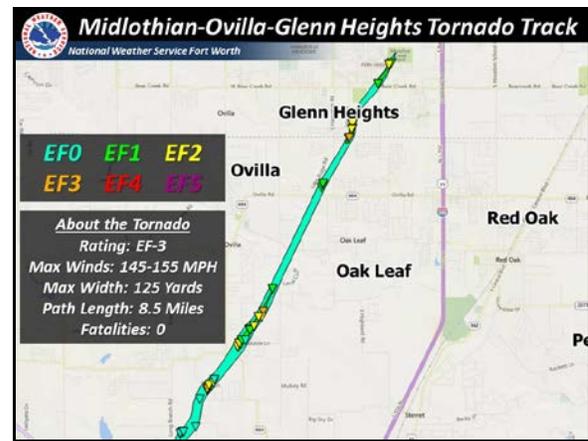
The damage survey team found two major tornado tracks near Dallas, Texas. One tornado traveled from Midlothian to Ovilla to Glenn Heights and will be referred to herein as the MOG tornado. This tornado traveled 14 km, was up to 110 m wide, with maximum damage intensity of EF3 (Fig. 2). The other major tornado, produced by a second supercell, traveled from Sunnyvale to Garland to Rowlett and will be referred to herein as the SGR tornado. This tornado traveled about 21 km, was up to 500 m wide, with maximum damage intensity of EF4 (Fig. 3).

Fig. 2. Damage track of the MOG tornado.

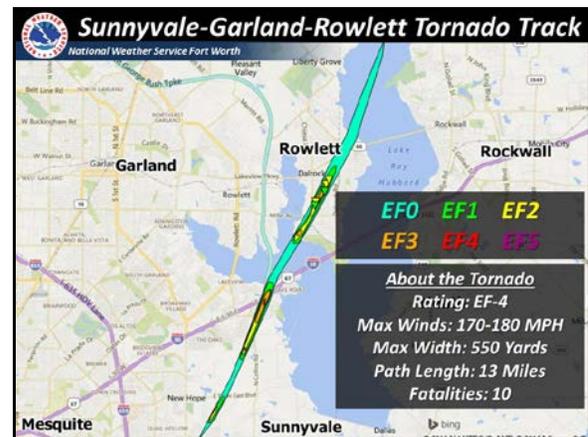
Fig. 3. Damage track of the SGR tornado.

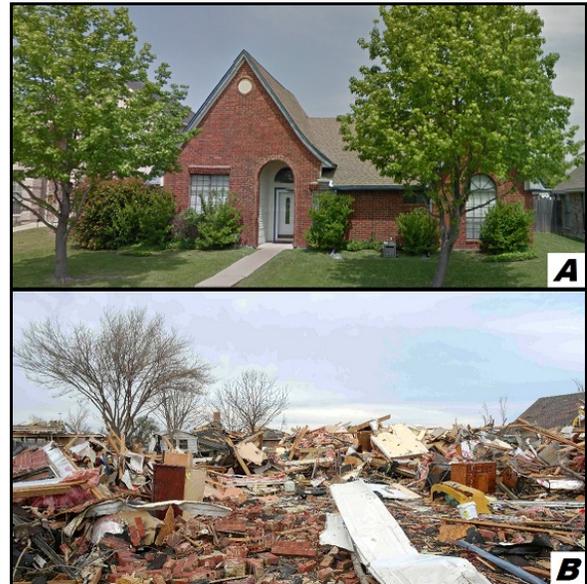
Fig. 15. View of a house taken (a) prior to the tornado using Google Street View and (b) after the tornado during our survey. Such images were helpful in determining various building characteristics.

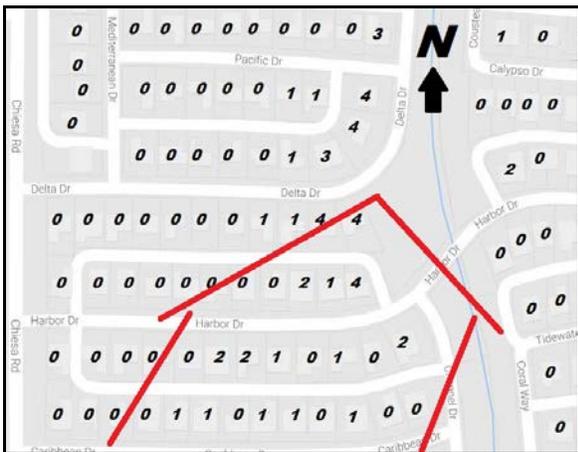
EF ratings were assigned to each damaged building, and numbers were plotted on Google Maps (Fig. 17). These maps also had outlines of buildings, making it easier to identify them in relation to trees and outbuildings. We also toggled between satellite images and road maps to verify locations of buildings, trees, and outbuildings. Similar damage survey techniques were done by Marshall et al. (2012) during the analysis of three Oklahoma tornadoes.

Fig. 17. EF scale ratings to buildings by block. The red arrow indicates direction of the SGR tornado.
