Hurricane Andrew 20 years later: What have we learned?

Timothy P. Marshall*, Kenneth Gilvary, and Justin Kestner Haag Engineering Co.

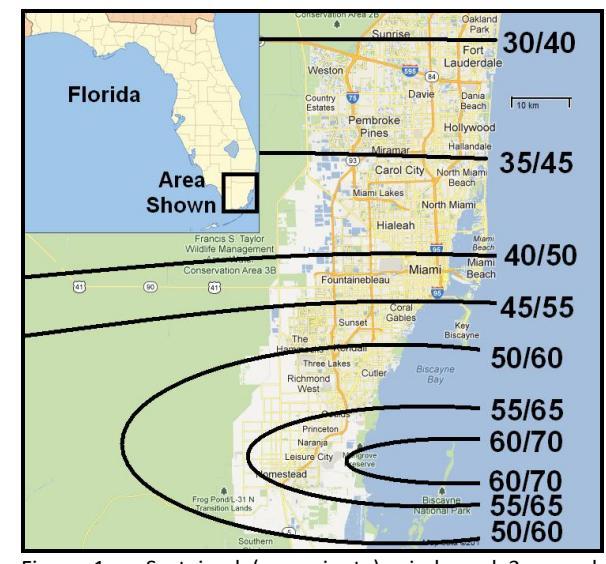
Figure 1a. Sustained (one-minute) winds and 3-second wind gusts estimated from the degree of building damage in south Florida after Hurricane Andrew. Wind speeds are in meters/second.

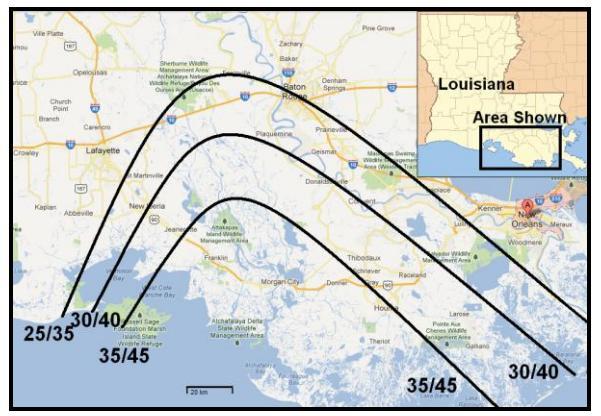
Figure 1b. Sustained (one-minute) winds and 3-second wind gusts estimated from the degree of building damage in southern Louisiana after Hurricane Andrew. Wind speeds are in meters/second.
