# Damage Survey of the Nashville, TN Tornado: 3 March 2020

Timothy P. Marshall<sup>1</sup>, Christine Standohar-Alfano<sup>1</sup>, Christopher Bright<sup>1</sup>, Krissy Hurley<sup>2</sup>  
<sup>1</sup>Haag Engineering Company, <sup>2</sup>NOAA/NWS

## 1. INTRODUCTION

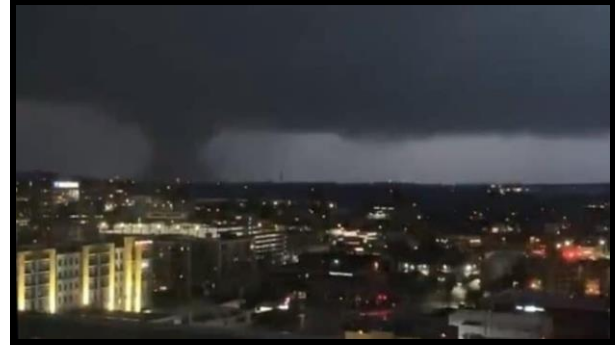
Fig. 1. The tornado going through Nashville.

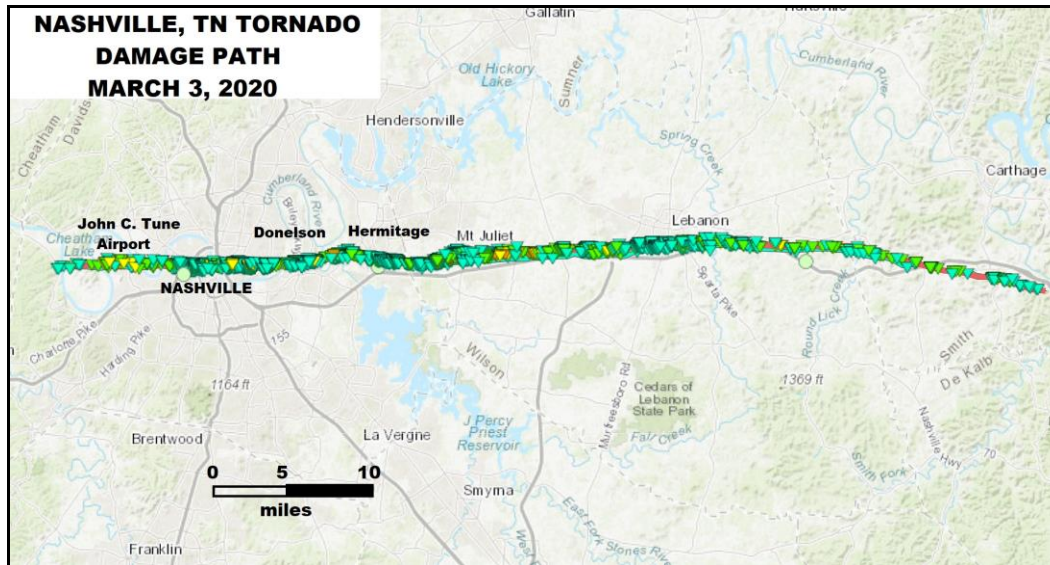
After this industrial area, the tornado weakened to EF 2 as it traveled into Lebanon damaging many homes including a strip shopping center. The tornado finally lifted east of Highway 141 southeast of Gordonsville around 0735 UTC. Refer to Figure 2.

Fig. 2. DAT track of the Nashville tornado. Source: NWS
