# Damage Survey of the Mayfield, KY Tornado: 10 December 2021

<sup>1</sup>Haag Engineering Company

<sup>2</sup>NOAA/NWS

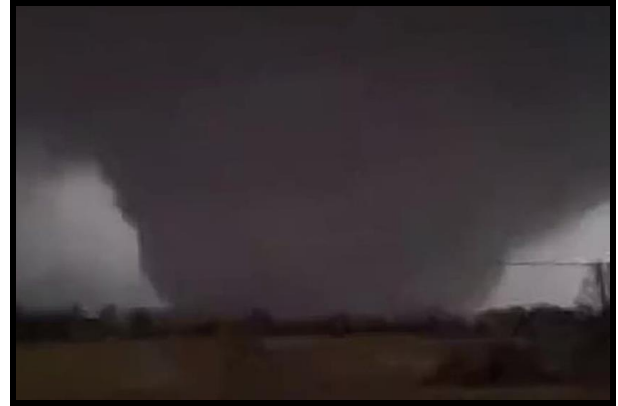
**Fig. 1.** Nighttime wedge tornado illuminated by lightning between Bremen and Sacramento, KY. Image by Eddie Knight.

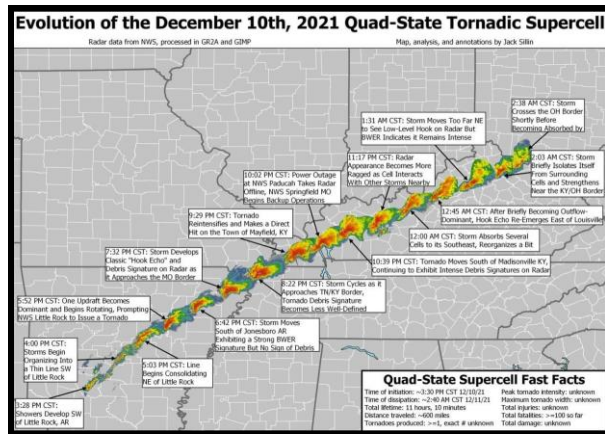
**Fig. 2.** Track of the supercell which produced the long-tracked tornado that went through Mayfield and Dawson Springs, KY. Source: NOAA.

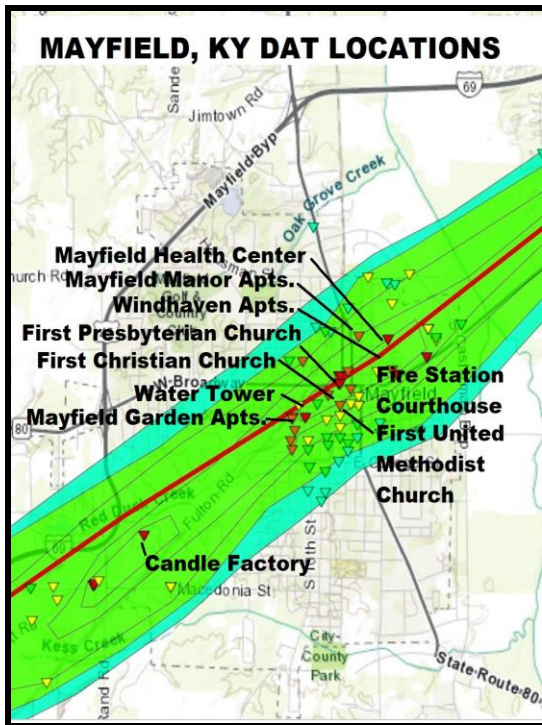
**Fig. 3.** DAT locations along with some of the specific buildings selected for detailed examination in Mayfield, Kentucky.
