Timothy P. Marshall, P.E.
Haag Engineering Co.

1. INTRODUCTION

The purpose of this paper is to discuss the characteristics of building damage associated with storm surges. As water rises, a combination of hydrostatic and/or hydrodynamic forces develop on inundated buildings. Wood-framed structures float in water, and movement of water can undermine and dismantle buildings from below. Recognizing how storm surge damages buildings can help damage investigators better separate wind and water damages.

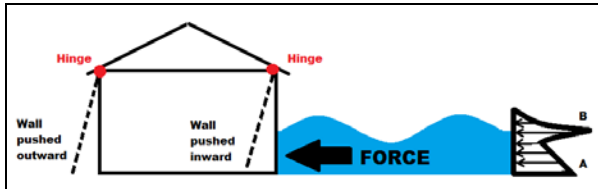
Damage associated with moving water is concentrated in the lowest portions of buildings and typically involves undermining or dismantling the buildings from below. Walls facing moving water can be pushed inward at their bases forming hinges at the tops of the walls. Similarly, the bases of walls on the leeward sides of buildings can be pushed outward (Fig. 1). Thus, buildings can collapse even if they are above the water level. The roof remains upright and floats downstream.

Figure 1. Illustration showing the forces of moving water against a wood-frame building: A) hydrostatic force and B) combination of hydrostatic and hydrodynamic forces in the wave zone. The bases of walls are pushed inward on the upstream sides and outward on the downstream sides of a building. As a result, hinges (red dots) form at the tops of the walls.
