828 Damage Survey and Analysis of the 20 May 2013 Newcastle-Moore EF-5 Tornado

Kiel Ortega^{1,2}, Donald Burgess^{1,2}, Gabriel Garfield^{1,3}, Christopher Karstens^{1,2}, James LaDue⁴, Timothy Marshall⁵, Tiffany Meyer^{1,4}, Brandon Smith^{1,2}, Richard Smith³, Doug Speheger³ and Greg Stumpf^{1,6}

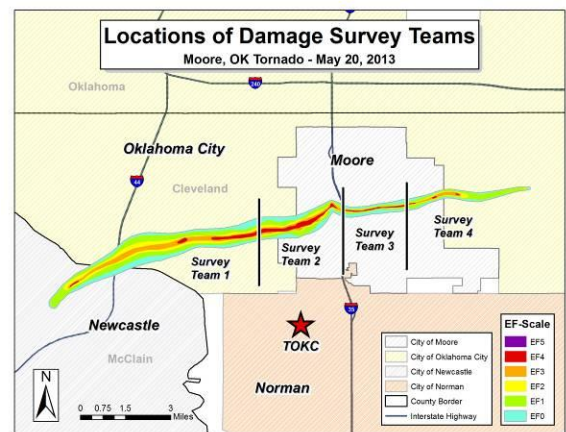
Figure 1: Path of the 20 May 2013 tornado and survey team areas.

Ground surveys were performed by four teams with each team responsible for a segment of the path (Fig. 1). Following the completion of

A quick review of the damage points reveals a fairly lopsided damage path, with the southern half typically a little further out from the damage centerline than the northern half (Fig. 1). It's entirely possible that some rear-flank downdraft damage was included on the southern periphery of the tornado path.
