HURRICANE IVAN DAMAGE SURVEY

Timothy P. Marshall*
Haag Engineering Co.
Dallas, Texas

1. INTRODUCTION

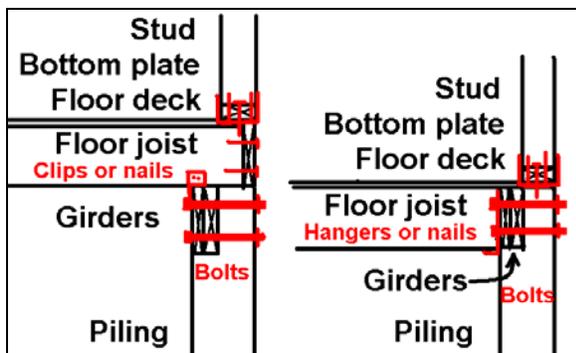
Wood girders were usually set into notches and bolted to the tops of the pilings. Wood floor joists extended perpendicular to the girders. About half the time, floor joists were installed in the same plane as the girders and hung by metal straps or just nailed to the girders. In other instances, the floor joists were set on top of the girders and were toe-nailed to the tops of the girders or secured with metal straps. The plywood subfloor was then nailed to the floor joists. Walls were then erected on top of the floor. Bottom wall plates were usually straight nailed or occasionally strapped to the floor framing (Fig. 13).

Figure 13. Different floor details on buildings elevated on timber piles.
