Timothy P. Marshall* Haag Engineering Co. Dallas, Texas

1. INTRODUCTION

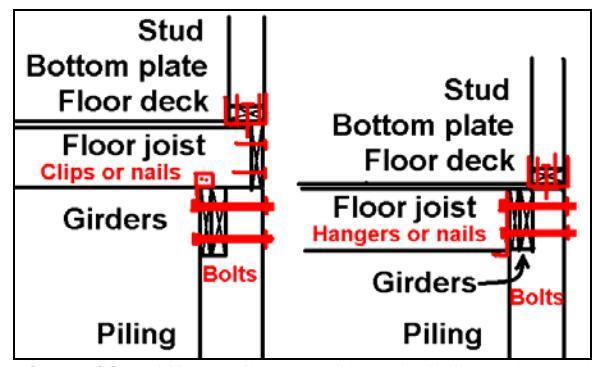
Wood girders were usually set into notches and bolted to the tops of the piles. Wood floor joists extended perpendicular to the girders. About half the time, floor joists were installed in the same plane as the girders and hung by metal straps or just nailed to the girders. In other instances, the floor joists were set on top of the girders and were toe-nailed to the tops of the girders or secured with metal straps. The plywood subfloor was then nailed to the floor joists. Walls were then erected on top of the floor. Bottom wall plates were usually straight nailed or occasionally strapped to the floor framing (Fig. 23).

Figure 23. Different floor details on buildings elevated on timber piles.

Storm surge damage to buildings elevated on timber pilings varied considerably from none to complete destruction depending on the height of the building above the water, depth of the pilings, and exposure to wave action. Not surprisingly, buildings adjacent to the coast suffered the greatest structural damage from the storm surge. Minor damage involved removal of cross bracing between the pilings. Moderate damage involved eroding sand around the bases of the pilings and rotating the pilings. Concrete slabs around the pilings were left elevated or collapsed when sand was removed. Severe damage involved broken and crushed pilings causing partial or complete collapse of the building.
