Timothy P. Marshall* and Stuart Robinson

1. INTRODUCTION

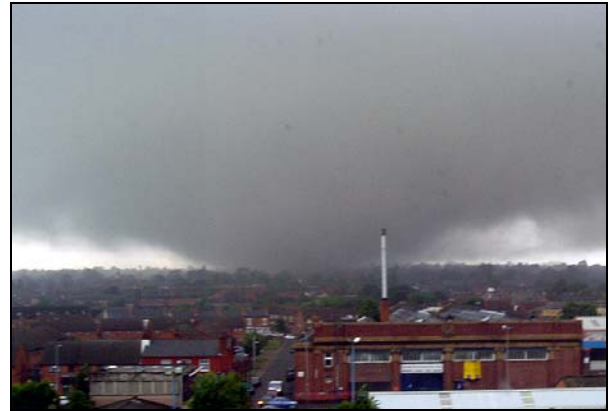
Figure 1. The Birmingham U.K. tornado. Photograph courtesy of Sasha Roberts.

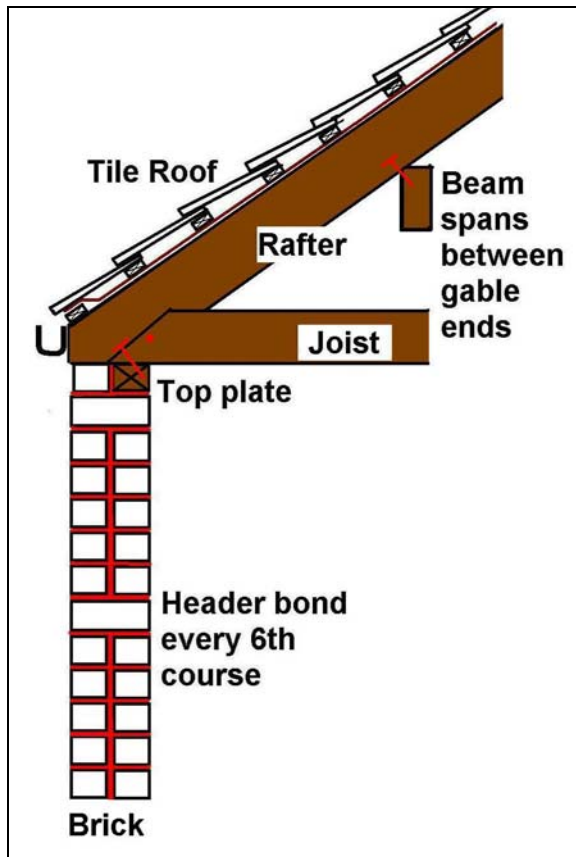
Most buildings damaged by the tornado had loadbearing brick masonry walls. Walls were double wythe in cross section with every sixth brick course turned perpendicular to the wall face in order to attach both wythes to each other (Fig. 10). Gable ends also were constructed with double wythe brick masonry. In essence, gable ends were free standing and had little resistance to lateral wind forces. As a result, the gable ends were susceptible to toppling in high winds leading to collapse of the roof (Fig. 11). Fortunately, such gable end failures were relatively rare due, in part, to the heavy weight of the slate and tile roofs that kept gable ends intact. But, falling masonry was quite hazardous crushing a number of cars. Some brick masonry chimneys fell into buildings, penetrated wood floors, and ended up on the first stories (Figs. 12 and 13).

Figure 10. Cross section of typical loadbearing brick masonry building in the tornado damage path. Roof beam spanned between gable end masonry.
