8B.3

Damage survey of the Greensburg, KS tornado

Timothy P. Marshall*
Haag Engineering Co.
Dallas, TX

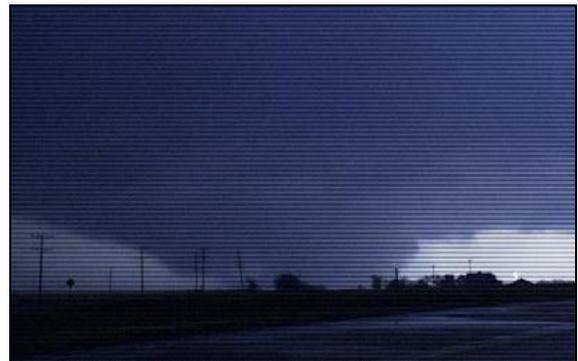
Figure 1. Lightning illuminates the Greensburg, Kansas Tornado. Image courtesy of Melanie Metz.

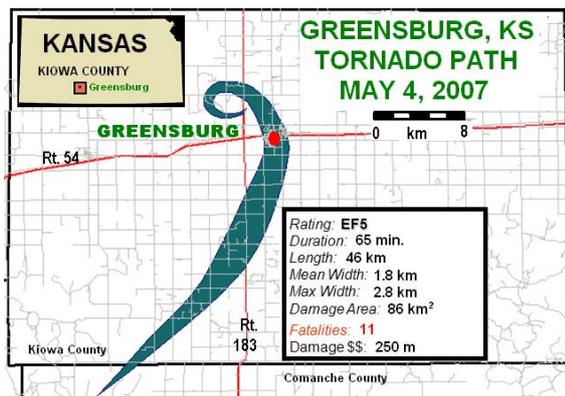
According to Umscheid and Lemon (2008), the tornado traveled 46km and was on the ground for 65 minutes (Fig. 2). Average path width was 1.8 km with a maximum path width being 2.8 km. Total damage area covered nearly 86 km^2 . The tornado initially touched down in Comanche County and traveled north-northeast into Kiowa County then gradually turned to the north-northwest when it struck Greensburg. The tornado traveled through the middle of town destroying the downtown business district and damaging or destroying more than 500 homes. The High School, Elementary School, and Hospital also were heavily damaged.

Figure 2. Damage path of the Greensburg, KS tornado. Courtesy of Umscheid and Lemon (2008).
