ANALYSIS OF CAUSES OF ICING CONDITIONS WHICH CONTRIBUTED TO THE CRASH OF CONTINENTAL FLIGHT 3407

P3.3

Frederick R. Mosher*, Debbie Schaum, Chris Herbster, Tom Guinn

Embry-Riddle Aeronautical University, Daytona Beach, FL

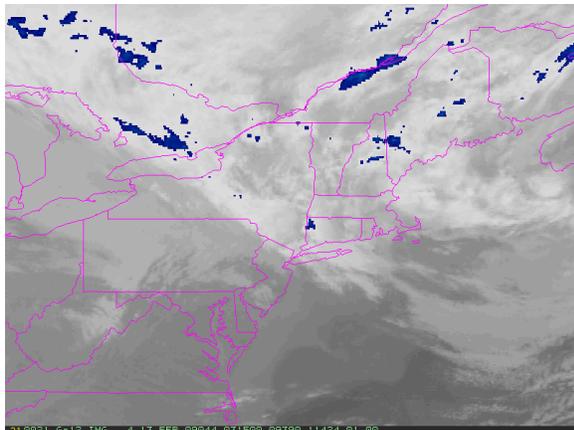
Figure 1. IR image 3:15Z

Figure 1 shows the IR satellite image for New England while Figure 2 shows a blowup of the western New York region with enhancements showing the 0 to -10 range (yellows), -10 to -20, and colder than -20 (blues). The cloud top temperatures in western New York are -15 °C.
