HURRICANE IKE DAMAGE SURVEY

Timothy P. Marshall*
Haag Engineering Co.
Irving, Texas

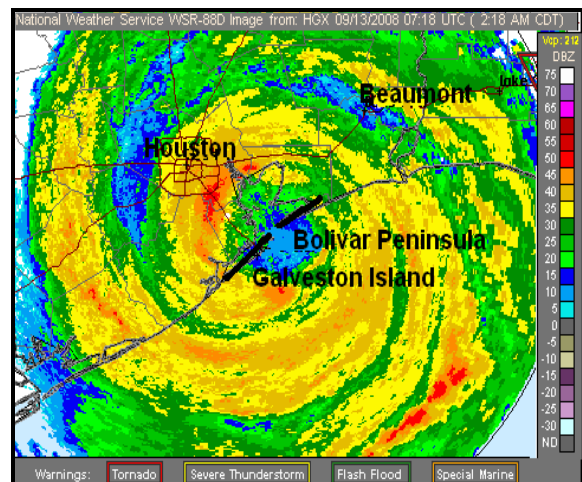
Hurricane Ike made landfall on Galveston Island around 0700 UTC on the morning of 13 September 2008 (Fig. 2). The estimated peak intensity at landfall on the Texas coast was category two on the Saffir-Simpson scale (Berg 2009). The 75 km wide eye traveled northward across Galveston Bay. The east eyewall passed over eastern portions of Galveston Bay and the Bolivar Peninsula. The west eyewall passed over western portions of Galveston Island and downtown Houston.

Figure 2. Radar reflectivity image (dBZ) of Hurricane Ike at 0718 UTC on 13 September 2008 as the eye made landfall on Galveston Island.

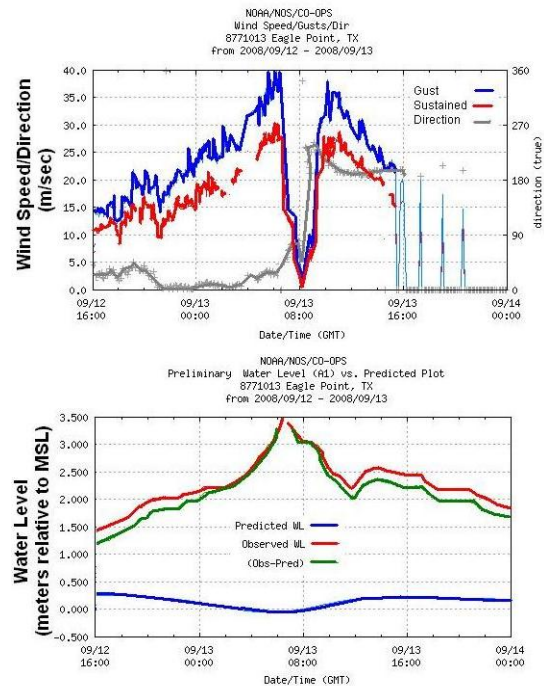
The National Ocean Service (NOS 2009) had 12 tide gauge stations in Louisiana and 13 in Texas at the time of Hurricane Ike. Some stations measured both wind and water levels. One such station was at Eagle Point in San Leon, TX on the west side of Galveston Bay (Fig. 13). Data recorded at this station indicated that water levels began rising the day before Hurricane Ike made landfall. Water levels were 1.5 m at 1600 UTC on 12 September 2008 and rose steadily to 3.64 m at 0624 UTC on 13 September 2008. Maximum (one-minute) sustained winds were 39.9 m s^{-1} from the northeast (029 degrees) at 0612 UTC in the north eyewall and 38.3 m s^{-1} from the southwest (213 degrees) at 1006 UTC in the south eyewall. Winds went calm briefly at 0812 UTC while the eye passed. Thus, the peak storm surge occurred near the time of maximum winds.

Figure 13. Wind (upper graph) and water levels (lower graph) at Eagle Point in San Leon, TX during Hurricane Ike showing the peak storm surge occurred near the time of maximum winds.
