THE ROLE OF LITIGATION IN THE DISCOVERY OF A PROBABLE UNDOCUMENTED F1 TORNADO IN MUNSTER, INDIANA (27 JUNE 1995)

Walter A. Lyons, CCM* Yucca Ridge Field Station, FMA Research, Inc, Fort Collins, Colorado

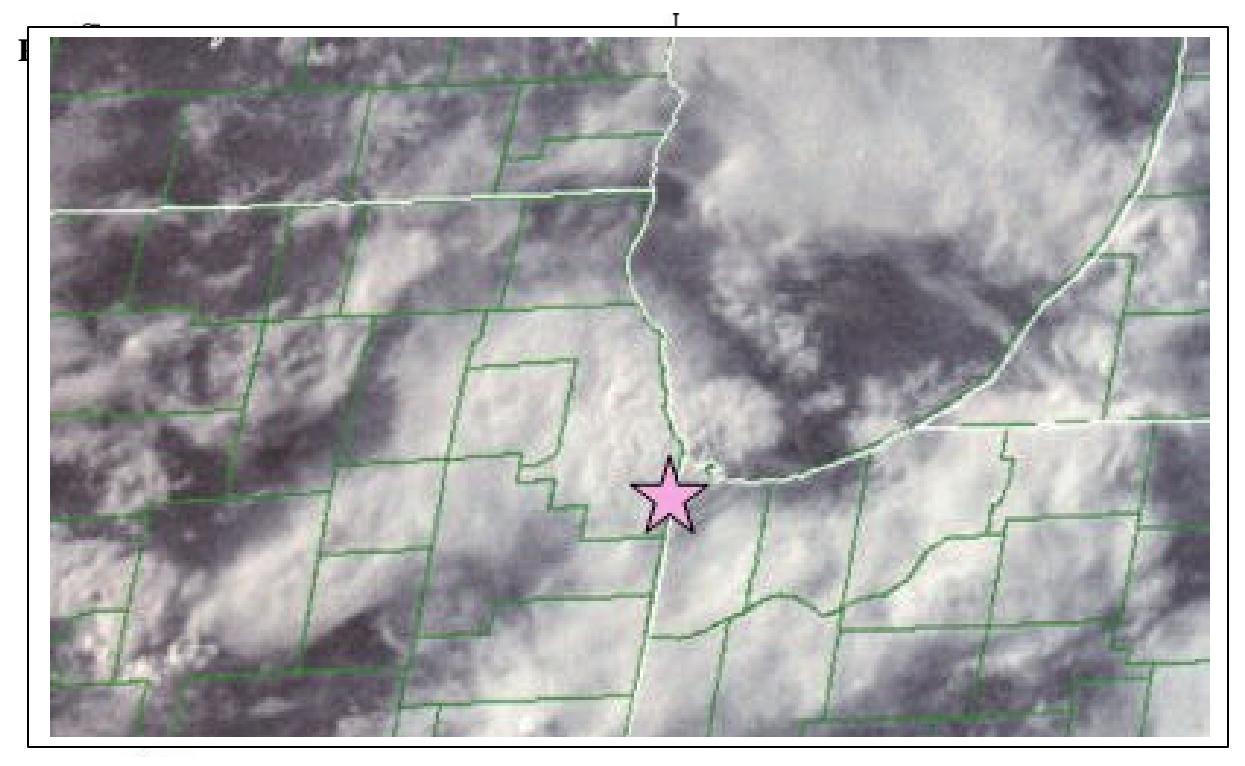
Figure 9 is the GOES visible image taken approximately 10 minutes after the major damage occurred in Munster (star). The multi-cellular nature of the convective development on this date is clear, which was very characteristics of early-summer coldcore low pressure systems. The wind damage occurred near the leading edge of the advancing cluster of thunderstorms.

Figure 9. GOES visible imagery, 2330 UTC, 27 June 1995. Star marks the location of the suspected F1 tornado 11 minutes before.

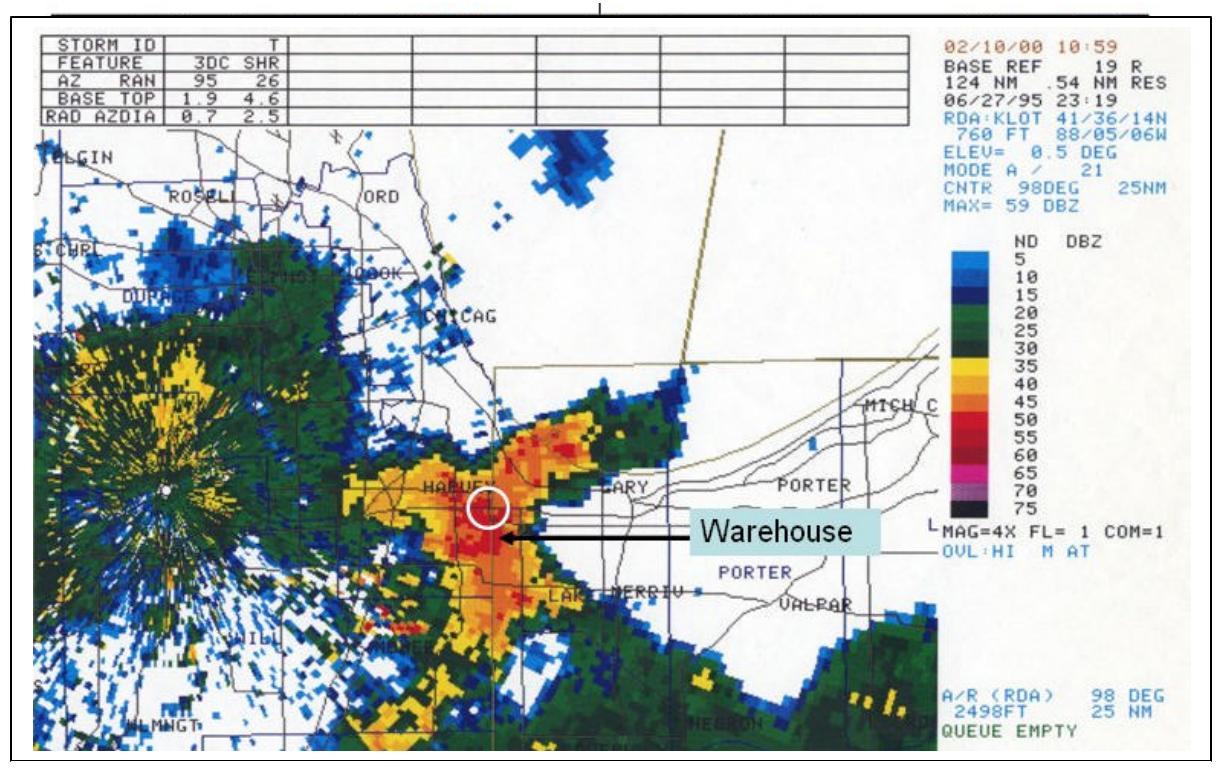
The KLOT base radial velocity display at 2319 UTC suggested outbound winds (assumed to be essentially westerly from the AWOS report) of 25-35 kts (29-40 mph) were passing over the warehouse. The base reflectivity at the same time showed the storm core with a 58 dBZ reflectivity approaching the warehouse. (At this range, the 0.5 degree beam height would be only 0.58 km above the radar). The mesocyclone detection algorithm located a 3D correlated shear just west of the warehouse at 2313 UTC. As shown in Figs. 10 and 11, this feature moved east-northeast, passing just to the north of the warehouse at the approximate tme of the damage (2319 UTC). It was located on the southern flank of the band of heaviest rainfall totaling 1.50 to 1.75 inches (not shown) and cloud-to-ground lightning activity (Fig. 11). The 3-D correlated shear feature persisted for another 30 minutes while the cell moved northeastwards. The 3-D shear feature was shallow (1.9 to 4.6 km) with radial and azimuthal diameters of 1.3 and 4.5 km respectively at 2319 UTC. While the evewitness description of the event suggests a vortex developing upward from the ground in classic gustnado fashion, there is some radar support for a weak circulation aloft which could have abetted the vortex development.

Figure 10. Romeoville, IL (KLOT) NEXRAD base reflectivity at 2319 UTC, 27 June 1995, within a few minutes of the expected tornado at the indicated location (warehouse). The 3-D correlated shear symbol is also highlighted in white. This circulation feature persisted for at least 30 more minutes.

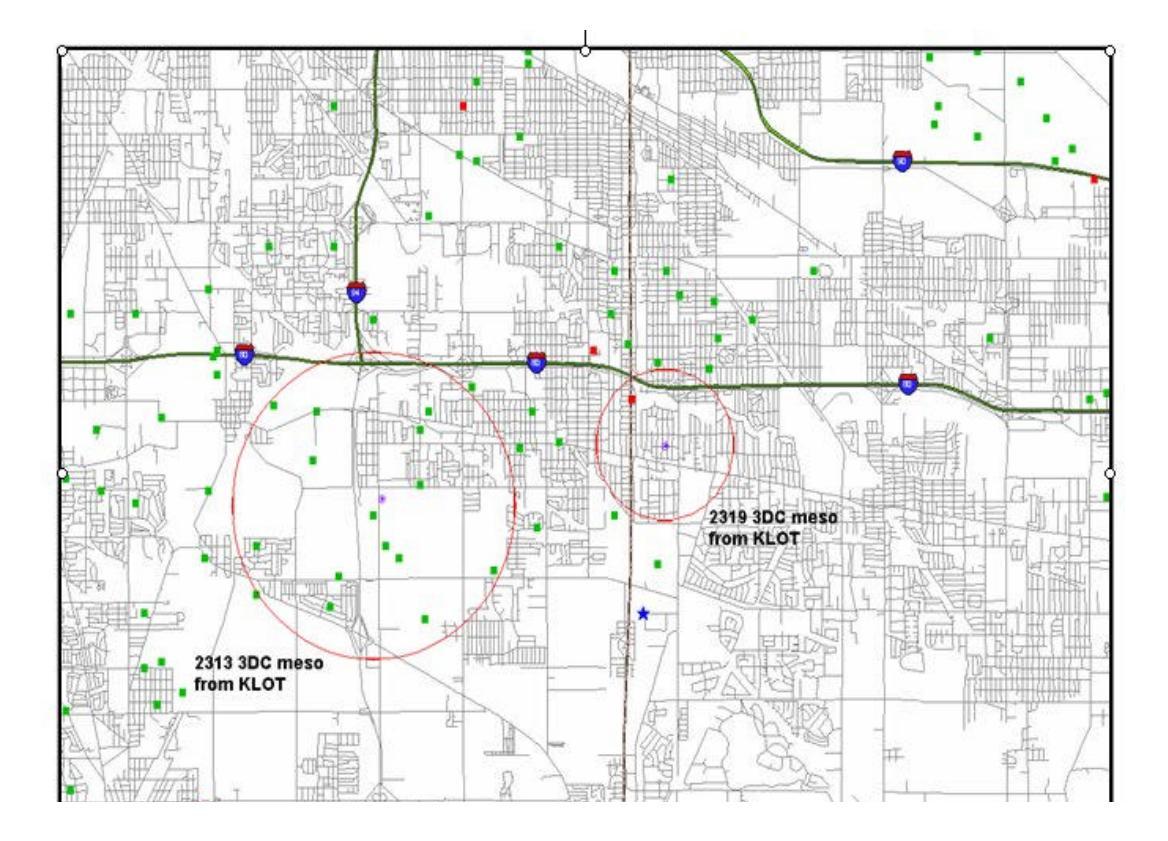
Figure 11. Location of 3-D Correlated Shear at 2313 and 2319 UCT, with the warehouse located indicated by a blue star. The green dots represent NLDN cloud-to-ground lightning flashes.
