By James G. LaDue\* NOAA/NWS Warning Decision Training Branch, Norman, OK and Kiel L. Ortega NOAA/NSSL/CIMMS, Norman, OK

#### 1. INTRODUCTION

8B.6

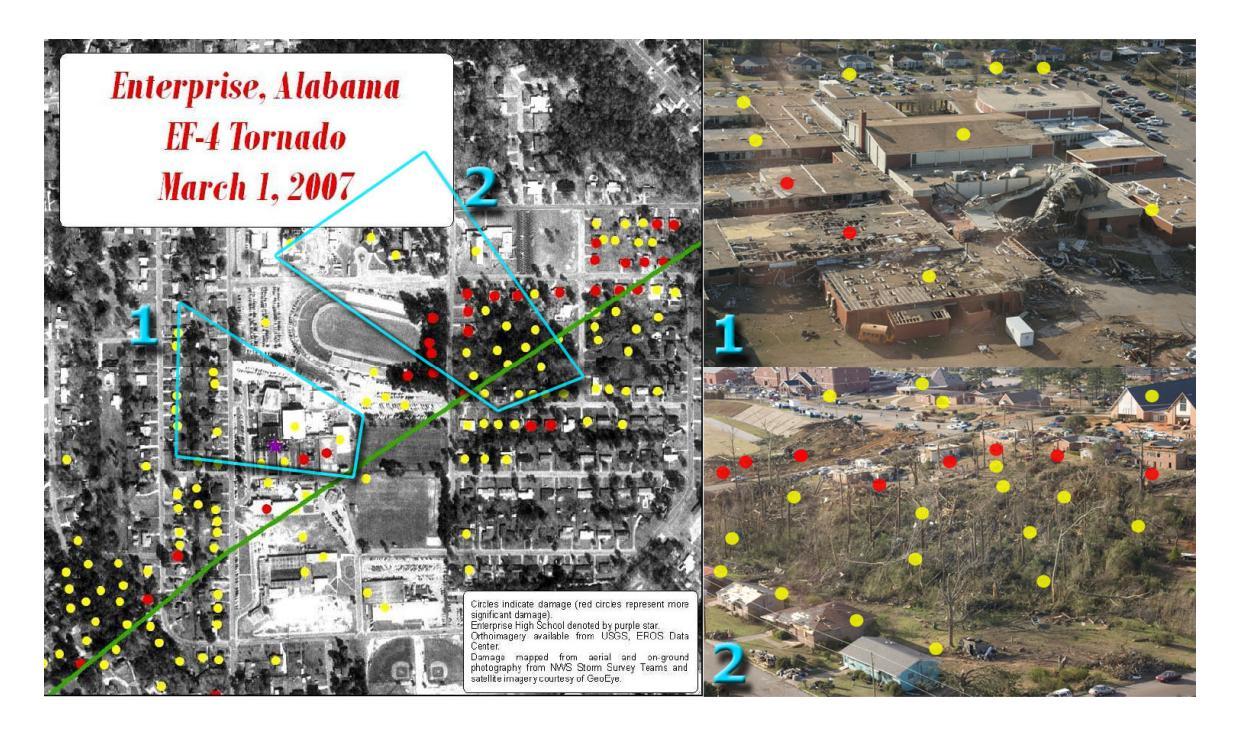
Figure 1. An aerial image highlights DIs chosen in a survey of the Enterprise, AL tornado. The image on the left shows light to moderately damaged DIs (yellow dots) indicating < EF2 and > EF2 damage (red dots). The blue polygons (labeled 1 and 2) represent the bounds of the photographs (1 and 2 respectively) taken by helicopter. The same DIs are plotted on each photograph in yellow and red. The center of the tornado track is marked by the green line on the left. Adapted by Camp, 2008.

Camp, 2008 used helicopter-based aerial imagery and GPS information shot by several surveyors (including the lead author) to generate a detailed GIS-based damage survey of the Enterprise, AL tornado of 2007

March 01. Surveyors carried the EFkit toolkit (LaDue and Mahoney, 2006), a GPS device for tracking, and digital cameras. The digital image locations were derived by comparing the image time stamps to the GPS timestamps. The process is somewhat labor intensive though it results in a highly detailed GIS-based survey as can be shown in figure 1. Note that Camp, 2008 treated the high school in image 1 as multiple DIs. The EF-Scale is originally intended to treat large Dis as single structure. However, the center of the tornado vortex was guite likely smaller than the high school and it consisted of multiple additions of different construction practices over a period of time making a single evaluation of the DOD for the structure problematic. The number of available Dis provided by the EF-Scale allowed for a detailed, GIS-based survey that is useful for any quantitative post-analysis. The

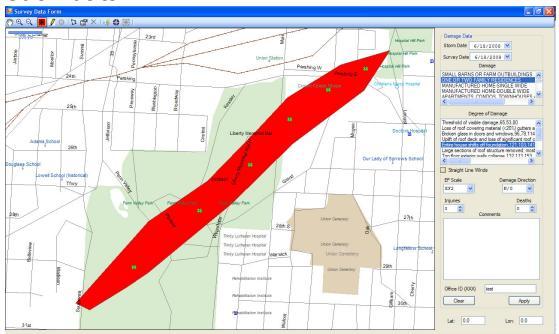
Figure 1. A user interface of a storm survey GPSbased tool.

A more preferable method of leveraging the advantages of the EF-Scale and GIS mapping would be to rate Dis directly in the field while a program automatically attaches location, time and other metadata (e.g., images, audio, text) explaining the rating. The authors know of one tool, The Storm Damage Survey Application, built at the NWS, Omaha office that allows a surveyor to geotag rated structures, assign direction of debris, and map the damage in real time (Griffis, 2007 personal communication) using a laptop or PDA. Figure 2 illustrates the user interface of this tool. The amount of time needed for post-processing a survey can be potentially greatly reduced providing an

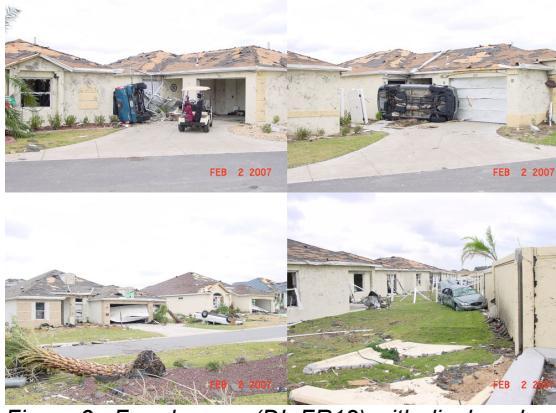
Figure 3. Four houses (DI=FR12) with displaced vehicles taken from Lady Lakes, FL (Photographs courtesy of NWS Tampa).

The following picture shows four houses in Lady Lakes, FL exhibiting loss of roof covering (DOD=4), and broken windows corresponding to a DOD=3 in the EF-Scale (fig. 3). This damage would typically yield an expected (maximum) wind speed of 43 m/s (51 m/s) respectively, or a standard EF1 rating with a possibility of going 2 m/s into the EF2 range. However, vehicles were rolled and moved in each of the photographs. Both Schmidlin, et al. 2002 and Marshall et al. 2008 found that only ~17% of typical passenger vehicles were rolled or lofted in EF3 and EF4 tornadoes while the number drops to  $\sim 2\%$  for EF1 and 2 tornadoes. Unfortunately, the authors did not have access to a similar survey from Lady Lakes, and therefore no definitive conclusion can be made about the strength of the Lady Lakes, FL tornado based on the percentage of vehicles upset. However, it is from the author's experience that upset vehicles are typically associated with at least an EF2 tornado. These houses performed extremely well in this tornado and represent an upper-bound to the construction quality allowed for this DI in the EF-Scale. They were constructed to post hurricane Andrew building codes with unreinforced masonry concrete block walls, and woodframe roofs connected with rafter clips to the walls. Had these houses been built with reinforced concrete walls, the standard oneand two-family house DI would certainly not be applicable.

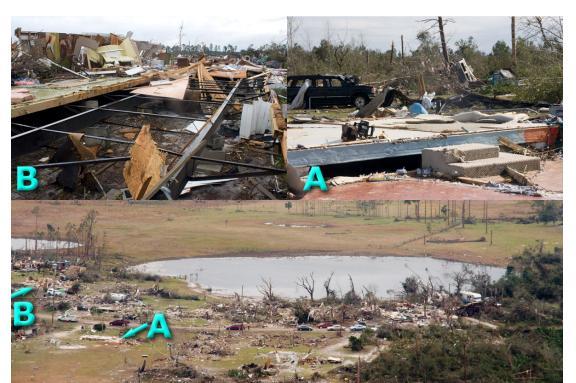
Figure 4. Photographs of two mobile homes A and B, taken from the air and ground. The arrows in the aerial picture indicate the direction of the phototograph. Images by Jim LaDue

Changing construction codes may also impact the sequence of DODs for any particular DI. An example of this problem may have been found in a mobile home park east of Lady Lakes, FL near Lake Mack. Several homes (both MHSW and MHDW) experienced complete destruction and yet their frames remained anchored to the ground (fig. 4). The mobile home at B agrees well with DOD=9 for a MHDW (Complete destruction of roof and walls leaving undercarriage in place) which corresponds to a lower end EF2. Inspection of mobile home B appeared to indicate that sidewall and frame ties may have been separated by less than 1.5 m, and provided anchoring that exceeded requirements required by the state of Florida's 1994 update (DHSMV, 2005). Surrounding tree damage is consistent with an EF2 as well. Mobile home A. a MHSW. had its walls and roof swept away with a DOD=6 being the closest description (Destruction of roof and walls leaving floor and undercarriage in place). An EF1 results from

the expected wind speed; however the upperbound wind speed corresponds to an EF2. Nearby tree damage indicates that EF2 would represent a lower bound rating, however. The weak point in the mobile home was likely associated with the 2X3" wall stud to base plate connections. Realizing the higher DODs for this DI may not be possible if there is a diversity in construction quality between various components.

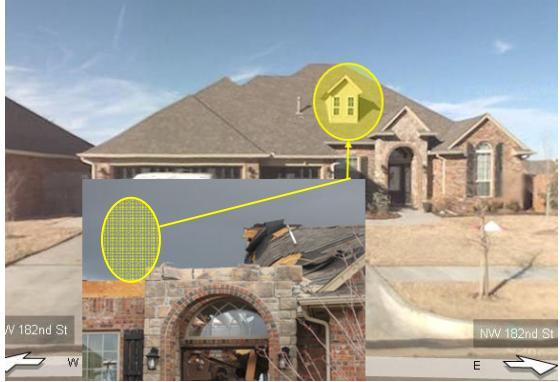
Figure 5. A surveyed house exhibited total failure of its roof on 31 March, 2008. A Dormer window is highlighted by the orange oval in the picture of the house before the damage occurred. The background picture is courtesy of Google while the damage picture was taken by Kiel Ortega.

to make sure that the primary DI is representative of that described in the EF-Scale (WSEC, 2007). If surrounding DIs show representative damage, then the confidence in the primary DI is increased, and so is likely the confidence of the tornado intensity rating. However, if the structure shows markedly different amount of damage that would correspond to a significantly different wind speed estimate than its surrounding DIs, then the primary DI should be rejected. This type of survey practice was borne out of the results from the LaPlata, MD tornado in which numerous weakly constructed homes were swept off their foundations while vehicles, trees, even mailboxes remained standing (Marshall, 2003). The house in figure 5 stands as an example where a small difference in construction, a dormer window or a weak garage door, may have resulted in a catastrophic roof loss (DOD=6) while surrounding homes experienced more minor roof damage (DOD=4). Standard practice would have a surveyor discount this particular house in the final tornado rating.

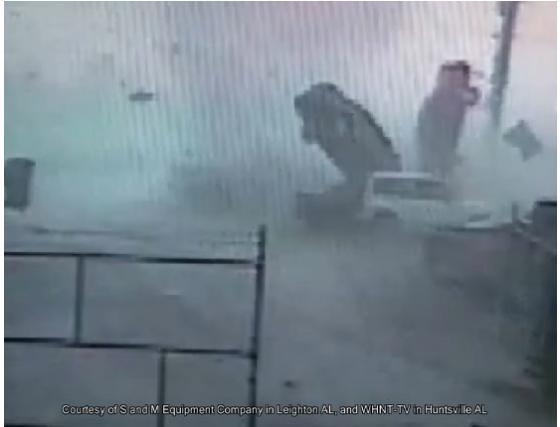
Figure 6. A single frame of a small end-wall tornadic vortex crossing the parking lot in Leighton, AL. Two vehicles are being upended in front and just right of the condensation funnel (center). Image courtesy of S and M Equipment and WHNT-TV.

However, there have been several events which have highlighted the extreme variability of wind in short scales including the video of the small end-wall vortex flipping vehicles in a Leighton, AL parking lot (fig. 6) that have called into question how close adjacent DIs must be in order for one to confirm the other.

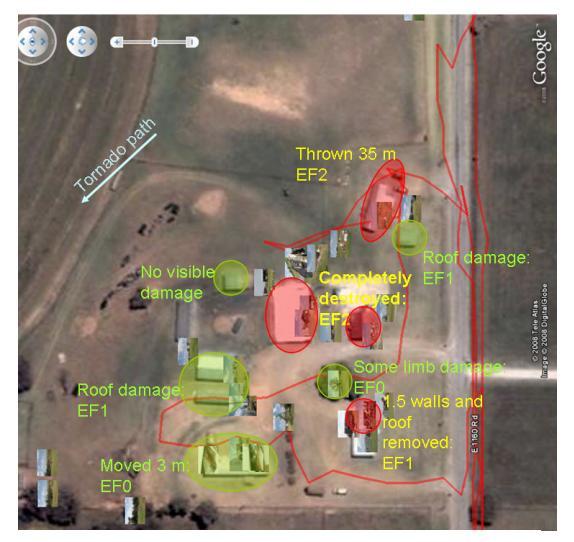
Figure 7. A ground-based survey of structures at a farmstead near Minco, OK from a tornado on 2007 August 19. The red trace represents the path of the surveyor took to investigate the structures. Pictures were geotagged and placed in a KML file to be displayed in Google Earth.

The variability in damage intensity between DIs presents a dilemma for surveyors such as the example shown in fig. 7 where one structure shows damage consistent with an EF2 next to structures showing little or no damage.

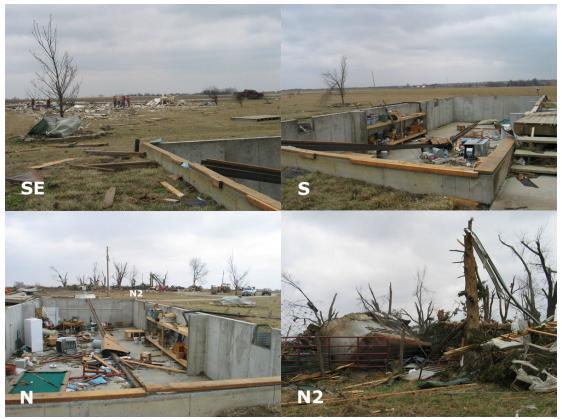
Figure 8. A house (FR12) experienced DOD=10 next to two saplings (TH) experiencing DOD<3. More mature trees experienced DOD=3 to 5 north of the house (bottom two panels). This image is provided courtesy of Evan Bookbinder NWS EAX.

On 28 February 2007, a severe tornado struck a well-built house and removed it from its foundation (figure 8). While remotely consulting with the surveyor, we noticed several saplings that suffered nothing more than snapped branches less than 10 m from the house (DOD=1, see the top two panels) while a grove of nearby trees suffered damage at least DOD=4. It is understandable that a surveyor may not consider saplings as a legitimate DI corresponding to soft- or hardwood trees. However, there have been other situations where even larger, but yet not mature, trees have experienced relatively little damage compared to other DIs in their proximity.

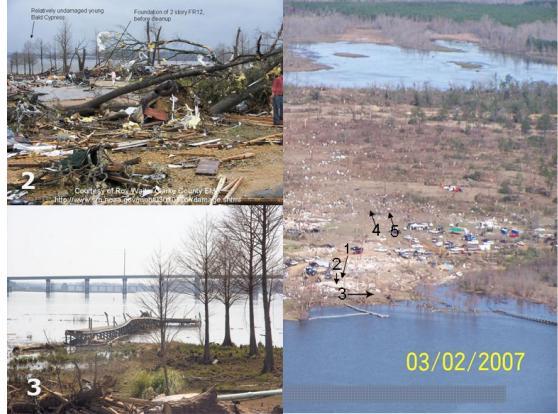
Figure 8. Damage at Millers Ferry, AL from 01 March, 2007. At right is an aerial picture facing northeast. The numbers correspond to photos including #2 (upper left) and #3 (lower right). The aerial photograph is taken courtesy of NWS Mobile. Photograph #2 is taken by Roy Waite. Photograph #3 is taken by Jim LaDue.

The case from Millers Ferry, AL from a violent tornado on 01 March, 2007 illustrates several Bald Cypress trees within 50 m southwest of two leveled, well built houses that experienced minor tree limb breakage corresponding to a DOD<3 (figure 8). The trees were further to the right of the tornado vortex core than the house but still well within the strong tornadic flow field as evidenced by the pier partially pulled out of the water behind them.

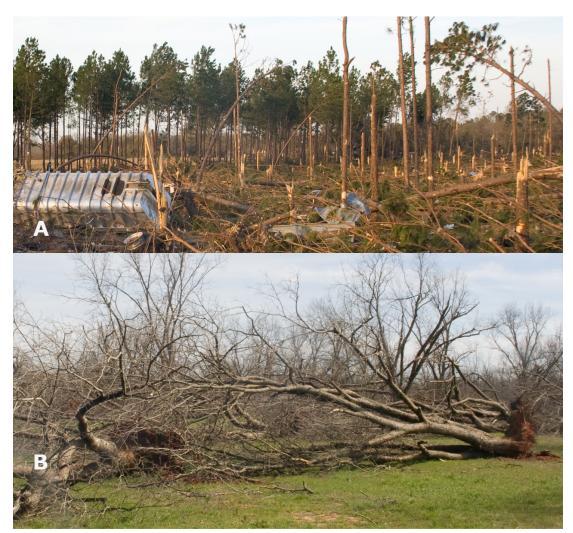
Figure 9. Tree damage observed from the Newton, GA tornado of 01 March 2007. The top image (A) represents snapped Slash pine trunks. The bottom image (B) represents uprooted Pecan trees.

A survey of the Newton, GA area tornado track from 01 March 2007 vielded a large majority of the Carya illinoinensis (Pecans) uprooted (TH, DOD=3) with no tree trunks snapped (figure 9a). Conversely, the Pinus palustris (Slash pine) experienced snapped trunks (TS, DOD=4) rather than uprooting (figure 9b). As a caution, these comparisons were made at quite a distance from each other. Yet, each species preferred to suffer two distinct types of catastrophic damage. We did not see a progression of trees uprooted to trees snapped from the periphery to the center of the tornado tracks in either the pine or the pecan groves as one would expect from the corresponding expected wind speed estimates from DOD=3 to DOD=4.
