# P7.114. EXTREME DAMAGE INCIDENTS IN THE 27 APRIL 2011 TORNADO SUPEROUTBREAK

## 1. INTRODUCTION

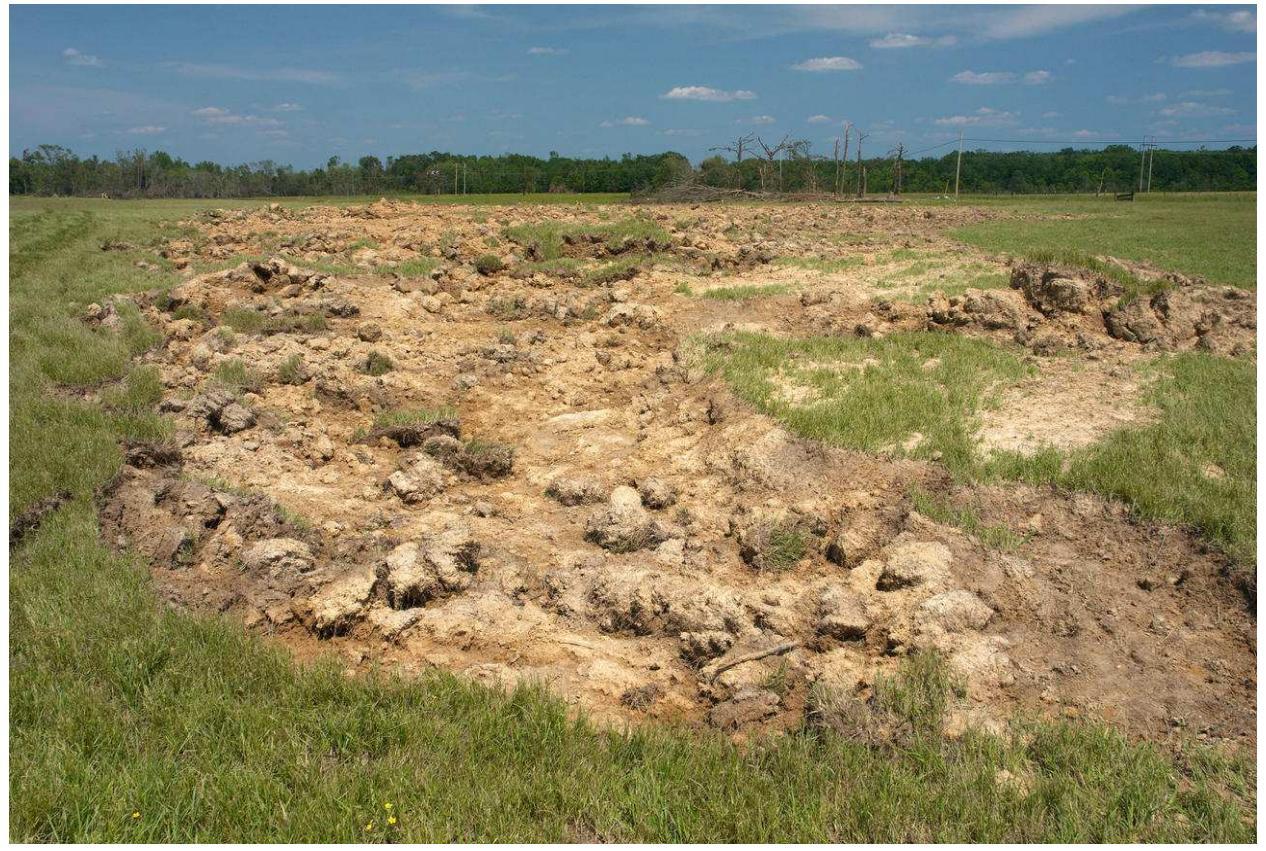
Fig. 1. In northeast Neshoba County, MS, an EF5 tornado ripped grass out by the roots from a farm field, leaving only swaths of rubble.

This tornado was the first violent tornado of the outbreak. After touching down near Philadelphia, MS, it raced northeast, increasing in size and violence. In northeastern Neshoba County, the tornado struck a grassy field, stressing the topsoil such that cracks formed, after which it lifted numerous grass clumps out of the ground by the roots, leaving swaths of plowed soil and rubble strewn across the field (Fig. 1). Many of the uprooted grass clumps were two feet deep. Two separate swaths of rubble were found, suggesting the action of suction vortices (Fig. 2). The tornado also snapped and uprooted numerous trees, ripped asphalt off roads, toppled gas station canopies and tossed mobile homes 300 m, killing 3 persons. The parent supercell spawned another tornado (EF1) in Noxubee County, before merging with another supercell and spawning three additional violent tornadoes (see Rainsville EF5 below). After the merger, the resulting Cordova, AL, supercell persisted for another 13.1 h before dissipating at night near Front Royal, VA.

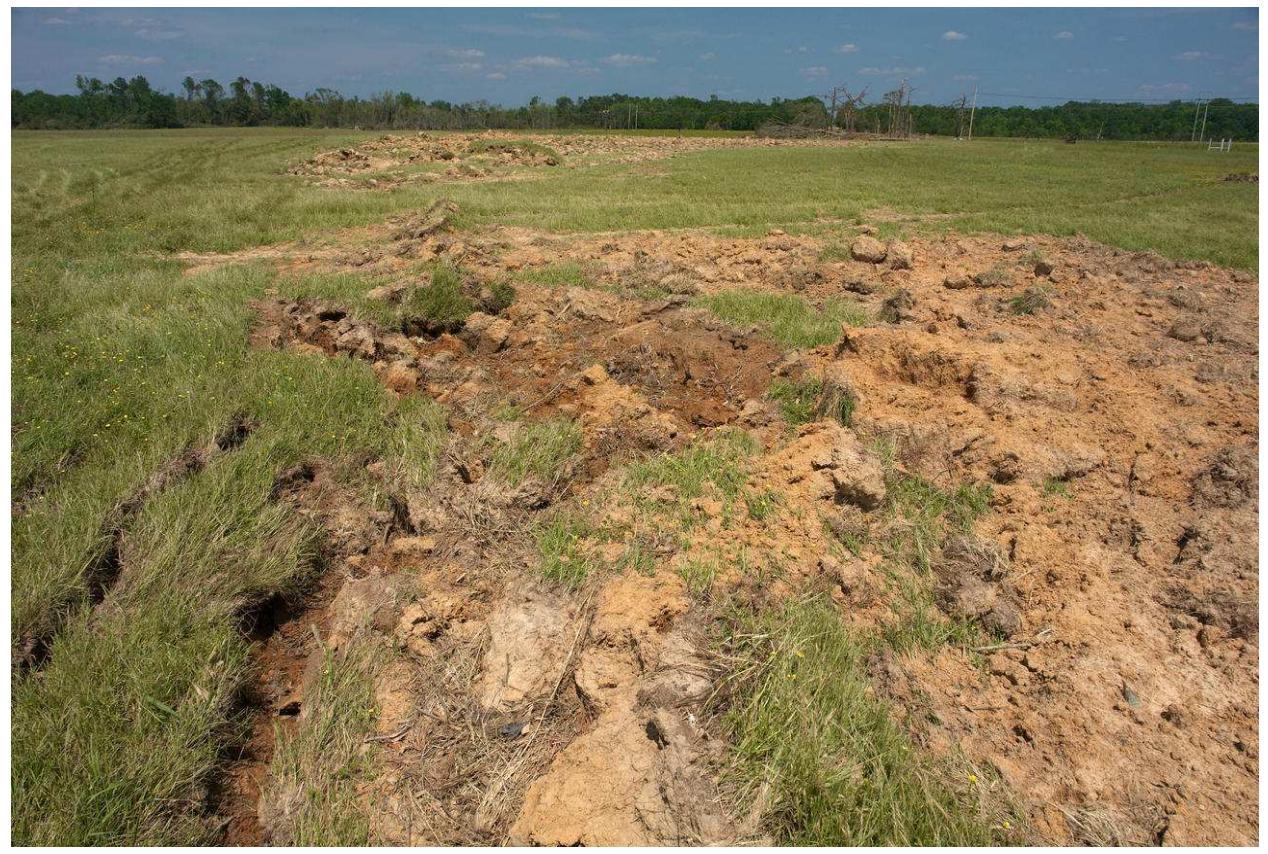
Fig. 2. There were two separate swaths of rubble, suggesting the action of suction vortices. Wind stresses evidently caused topsoil to fracture, initiating the damage.

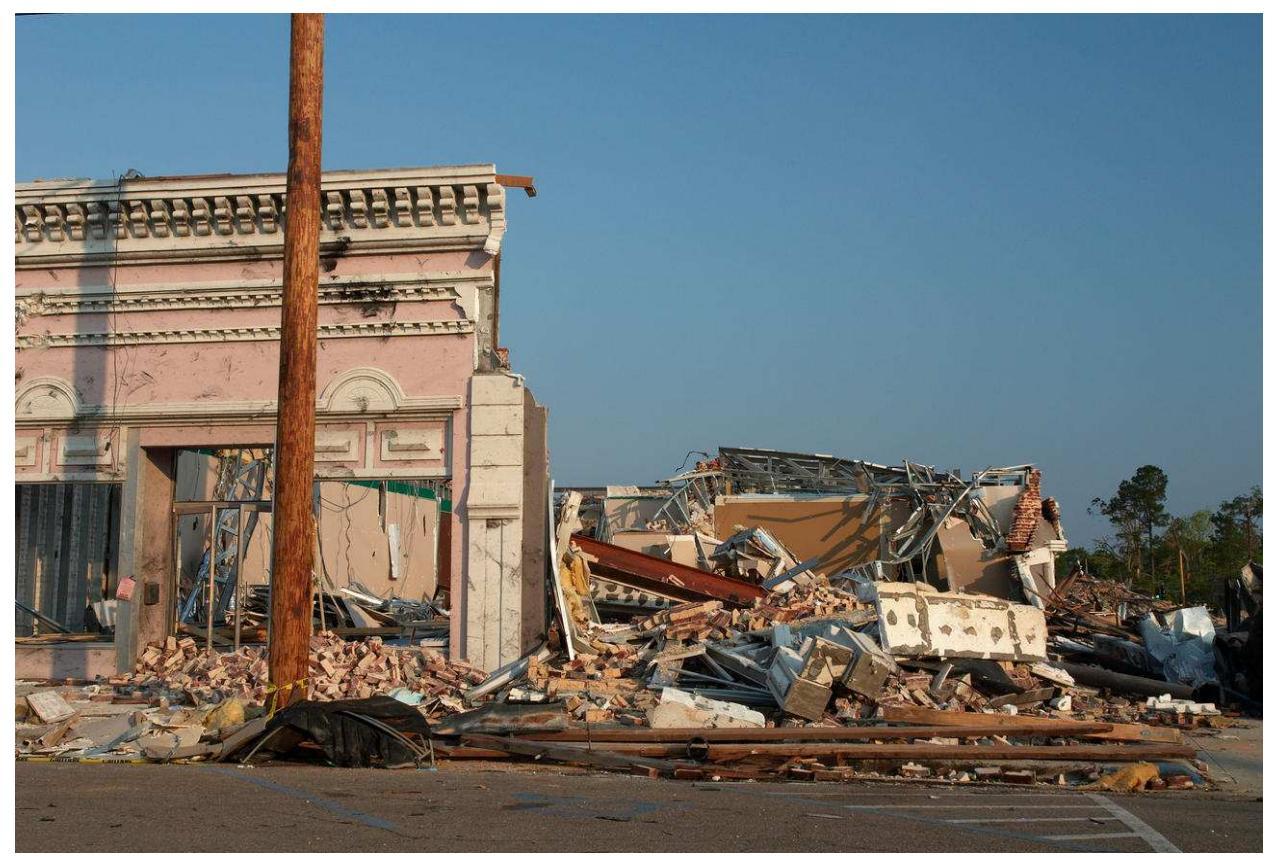
Fig. 3. In the historic district of Cullman, AL, an EF4 tornado caused old masonry structures to collapse.

This tornado formed just southwest of the city of Cullman, then proceeded to strike the historic downtown sector of the city, where it wrecked many longstanding structures (Fig. 3). Already violent, the tornado increased in size as it marched across rural areas northeast of Cullman. It widened to approximately 1 mile after passing through Hulaco in southeast Morgan County, then reached peak intensity as it plowed through the Hog Jaw and Ruth communities northwest of Arab, where it swept recent-vintage homes from their foundations, killing 5 in one house (Fig. 4). Radars detected tornadic debris signatures extending up to 7 km altitude with this storm (Knupp et al. 2013). The tornado ultimately descended into the Tennessee River valley just west of Guntersville Dam, and dissipated in northern Marshall County. The parent supercell went on to produce two other EF4 tornadoes, and persisted for a total of 11.5 hours, finally weakening and merging with smaller storms at night in eastern West Virginia.

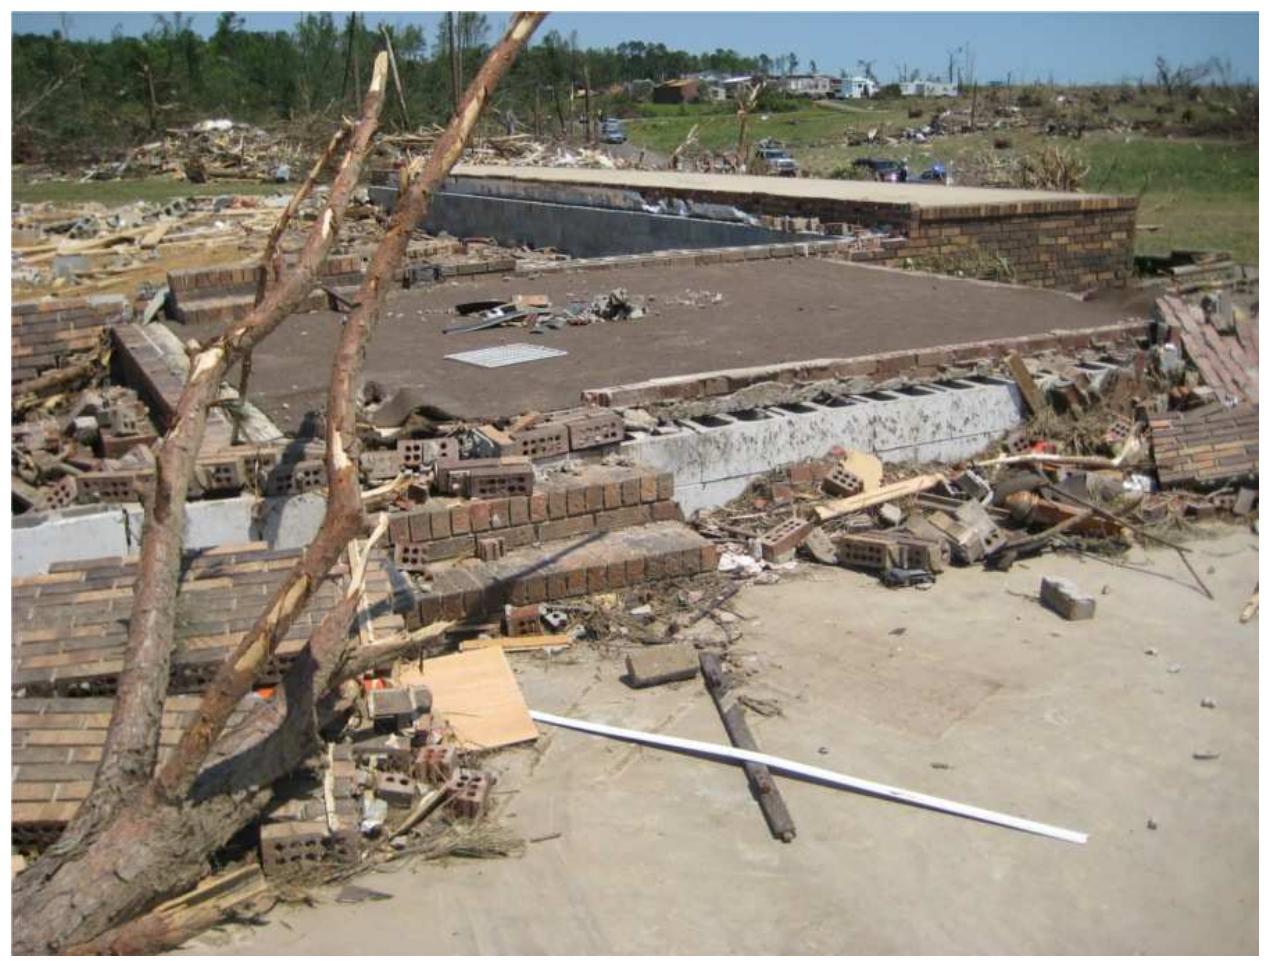
Fig. 4. Farther northeast, as the Cullman tornado moved into Marshall County at peak size and intensity, modern-vintage brick homes were swept away, resulting in five deaths.

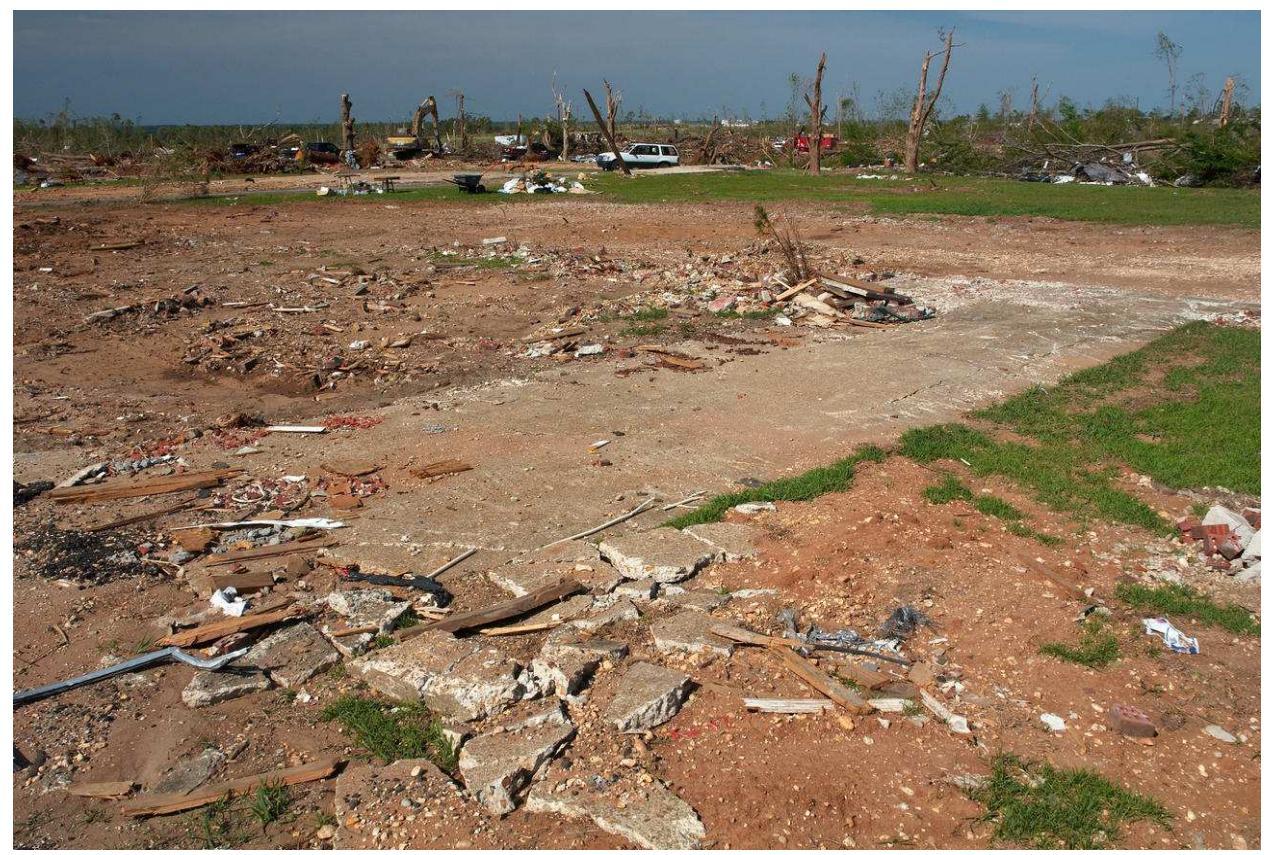
Fig. 5. In Hackleburg, AL, an EF5 tornado obliterated the north side of town.

This historic tornado, possibly the most violent of the entire outbreak, began in Marion County, AL. Its first significant victim was the town of Hackleburg, whose entire northwest sector was essentially blown away by the then EF5 tornado (Fig. 5). The Wrangler Jeans plant, the town's main economic engine, was flattened, and samples of jeans were found in the town of Courtland, AL, some 46 mi northeast. The tornado wrought severe damage in Phil Campbell, AL, where trees were debarked and large expanses of asphalt were stripped from roads (Fig. 6). Farther downstream, in Oak Grove, AL, the tornado reached 1.25 mi width and major devastation occurred; one car was lofted and carried more than 640 ft. The tornado then ripped through Mt. Hope, AL, and marched towards the Tennessee River, narrowly missing the Browns Ferry Nuclear Power Plant. Many large trunk power lines were destroyed by the tornado, forcing a shutdown of the nuclear plant and plunging Huntsville and all of northeast Alabama into a 5-day power outage. After crossing the river, the tornado tore through Tanner, AL, and blew away the Doppler radar operated by WAFF-TV. In Madison County, the tornado skirted the northwestern suburbs of the cities of Madison and Huntsville, destroying several more subdivisions before weakening briefly. In then reintensified in Lincoln County, TN, and finally dissipated after staying on the ground for 132 mi, and killing at least 72 persons. Papers such as personal photographs from Phil Campbell were carried 353 km and dropped in Lenoir City, TN, by this tornado; this is believed to be a new record for

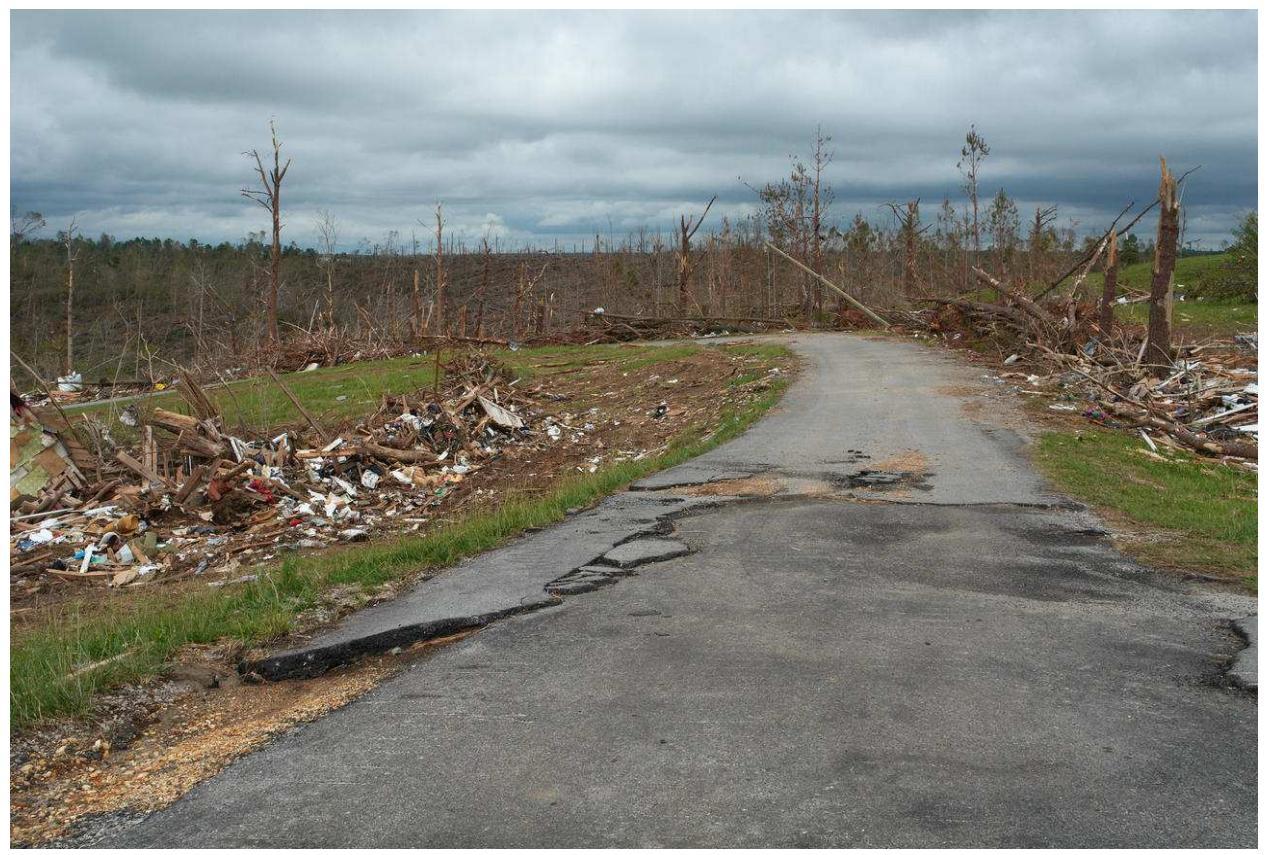
Fig. 6. In Phil Campbell, AL, the Hackleburg tornado continued at EF5 intensity, stripping pavement of roads. This giant tornado killed 72 in its 132-mi march across north Alabama and southern Tennessee.

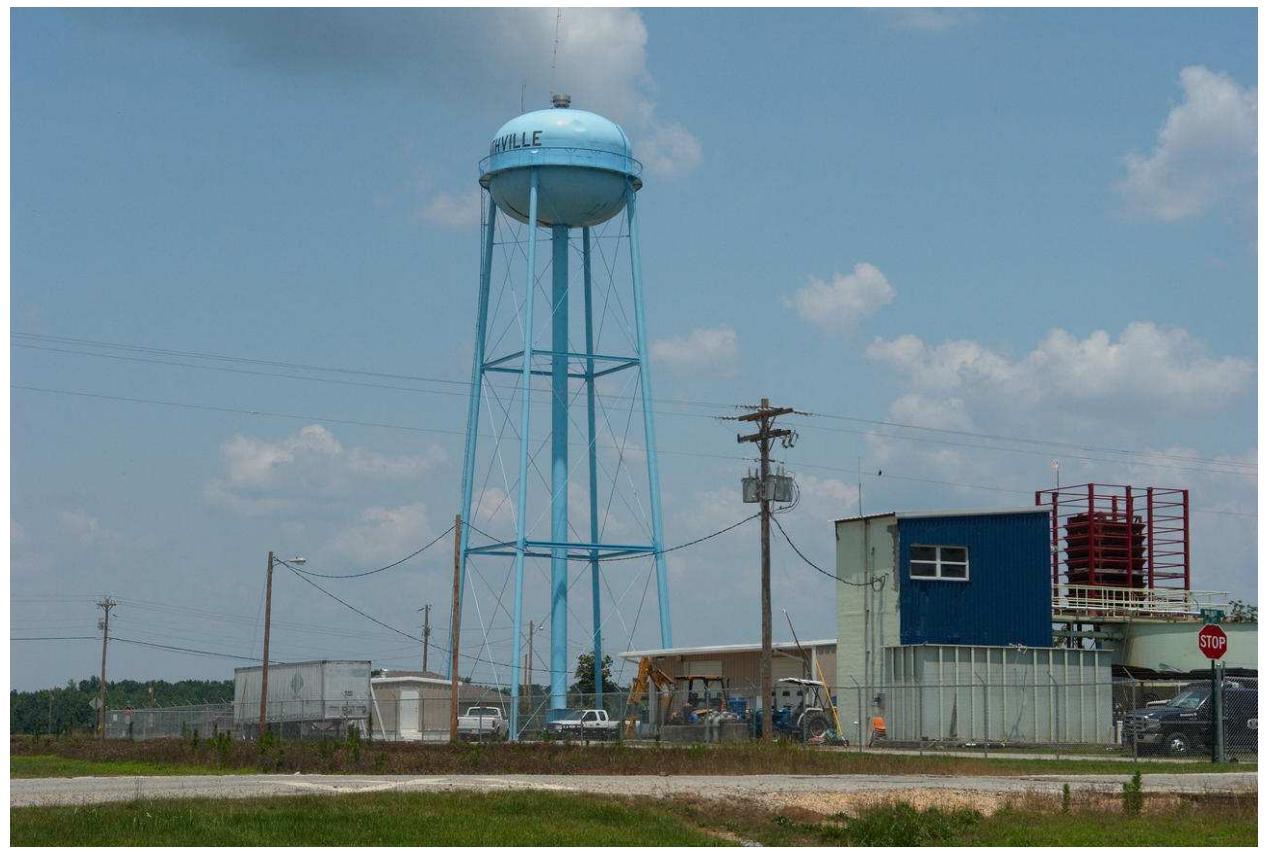
Fig. 7. In Smithville, MS, another EF5 tornado destroyed most of the town, hurling a Ford Explorer SUV 0.5 mi into the city's water tank, leaving a permanent dent in its side.

This violent tornado was the successor to another violent tornado in northeastern Mississippi, from a supercell some distance west of the Hackleburg supercell. The tornado swept away much of the town of Smithville, and lofted a large SUV 0.5 mi before throwing it into the town's water tower, where it left a large dent (Fig. 7); the SUV landed another 0.25 mi downstream in a crumpled ball. In the tornado's path, another pickup truck was lofted and has not yet been found; the owner, who survived by being not at home when the tornado struck, speculates that the truck may have been deposited in Pool B of the Tennessee-Tombigbee Waterway, some 0.3 mi north. Elsewhere in Smithville, a large bag containing an estimated 40 lb of athletic gear was carried 30 mi and dropped onto the town of Hodges, AL. Early reports on the internet that a steel drainage culvert had been ripped out of the ground by the tornado (Fig. 8) proved erroneous; Smithville police officials confirm that the street had been earlier declared unsafe, and that road crews had dug up the culvert to ensure no vehicular traffic could use it.

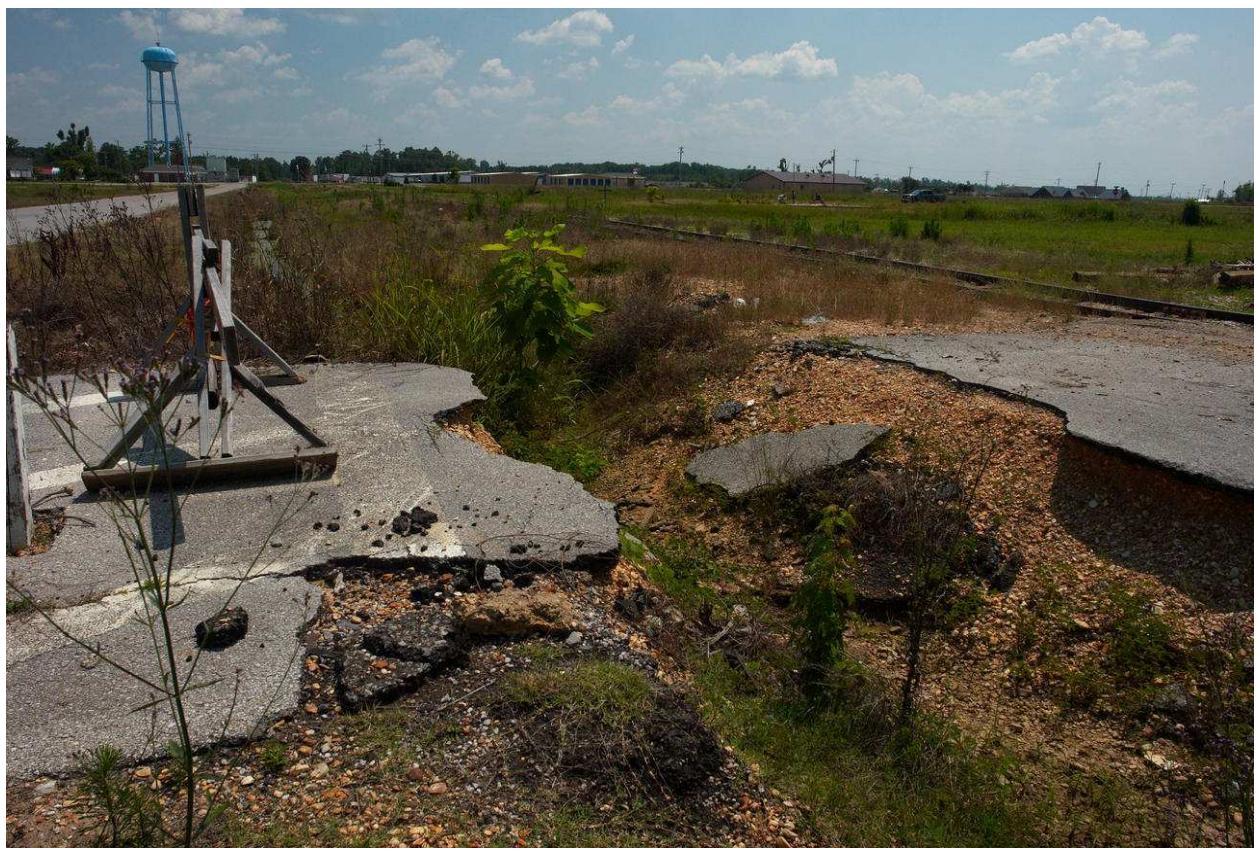
Fig. 8. Contrary to numerous early reports on internet sites, the removal of a steel drainage pipe from a Smithville street was not accomplished by the tornado. The street had been dug up earlier to ensure closure of an unsafe stretch of road to traffic.

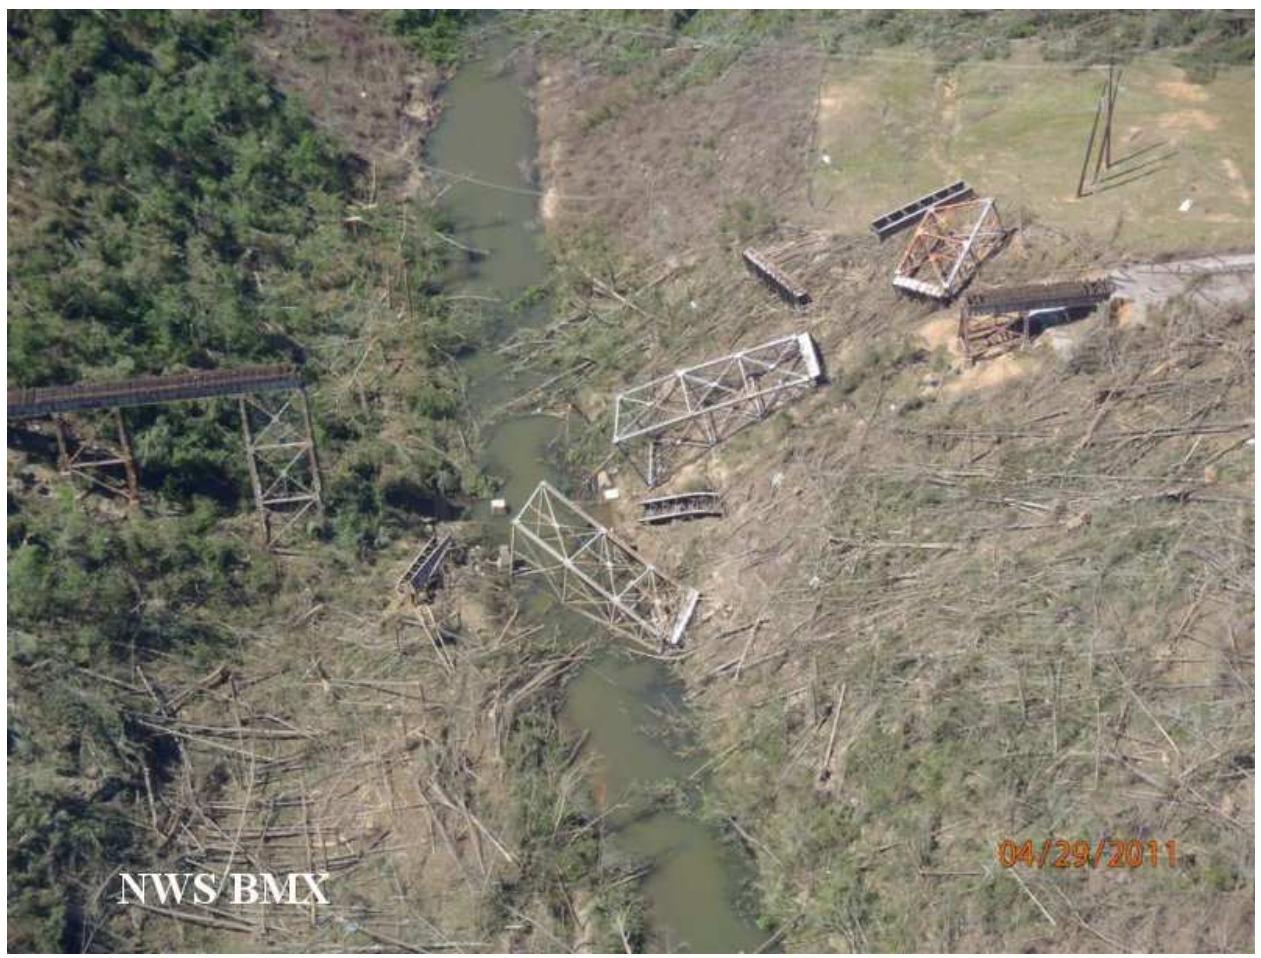
Fig. 9. Just northeast of Tuscaloosa, AL, a large and iconic tornado ripped a still-used steel railroad bridge to pieces, throwing and rotating one 34-ton truss tower uphill about 100 ft.

This large and iconic tornado was rapidly intensifying as it tore through the city of Tuscaloosa, wreaking historic damage. It reached an apparent maximum in intensity just northeast of town, where it struck a stillused steel train trestle over Hurricane Creek Canvon. ripping three of five tapered steel trusses off their concrete pads and tossing them around; one of the trusses, weighing some 34 tons, was rotated and carried about 100 ft uphill (Fig. 9). Forest in the vicinity of the trestle was almost completely blown down, and littered with fragments of vehicles and appliances. Farther downstream, the tornado roared across a coalyard, derailing 29 or 31 coal hopper cars and displacing one of the 35.8-ton cars 391 ft (Fig. 10). Eyewitnesses affirm that the car was lofted and not rolled. It is not unusual for tornadoes to topple and derail train cars, but to our knowledge, no other tornado in the prior historical record has displaced heavy railcars such distances. The tornado had widened to 1.5 mi diameter by the time it crossed I-65 north of Birmingham, and was the widest tornado reported in the entire outbreak. This tornado killed 64 persons and injured at least 1500 others.

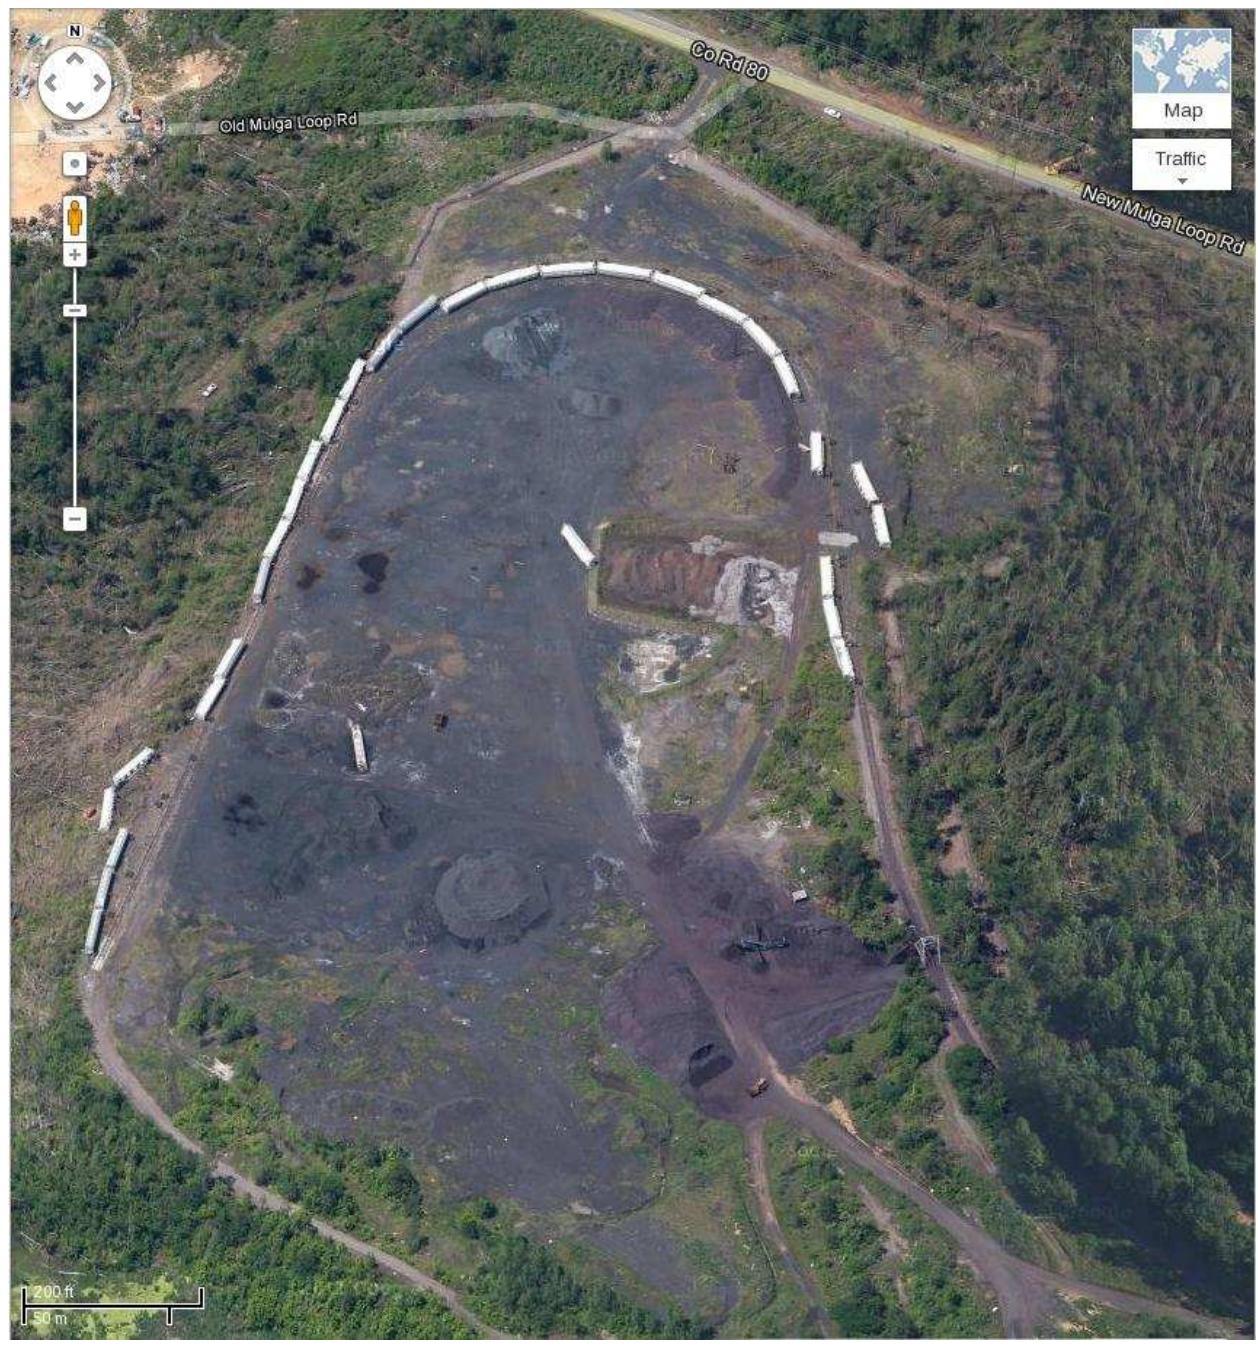
Fig. 10. Near Pleasant Grove, AL, the Tuscaloosa tornado swept across a coalyard rail depot, derailing 29 of 31 empty coal cars, and lofting one of the 35.8-ton cars an astounding 391 ft (center). This tornado reached 1.5 mi width, killed 64 persons, and injured 1500 others.

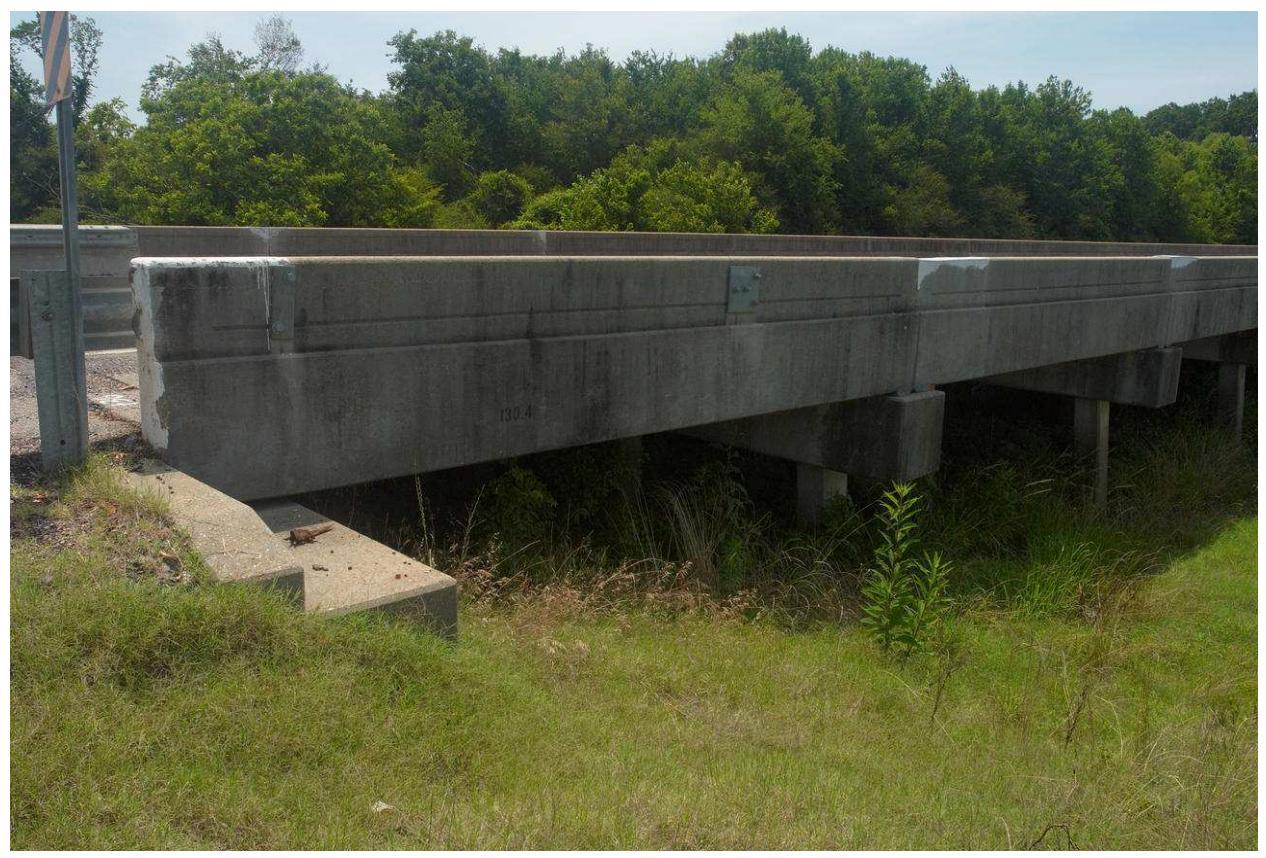
Fig. 11. Just south of Newton, MS, an EF3 tornado roared across a precast concrete highway bridge with such force that it lifted the highway decking slabs, and damaged the concrete railings (see white patches).

This tornado struck a precast concrete highway bridge over a creek, briefly lifting some of the highway decking slabs off their concrete frame piers, and damaging the concrete guardrails. White concrete patches still bear testment to the parts of the concrete that suffered damage (Fig. 11).

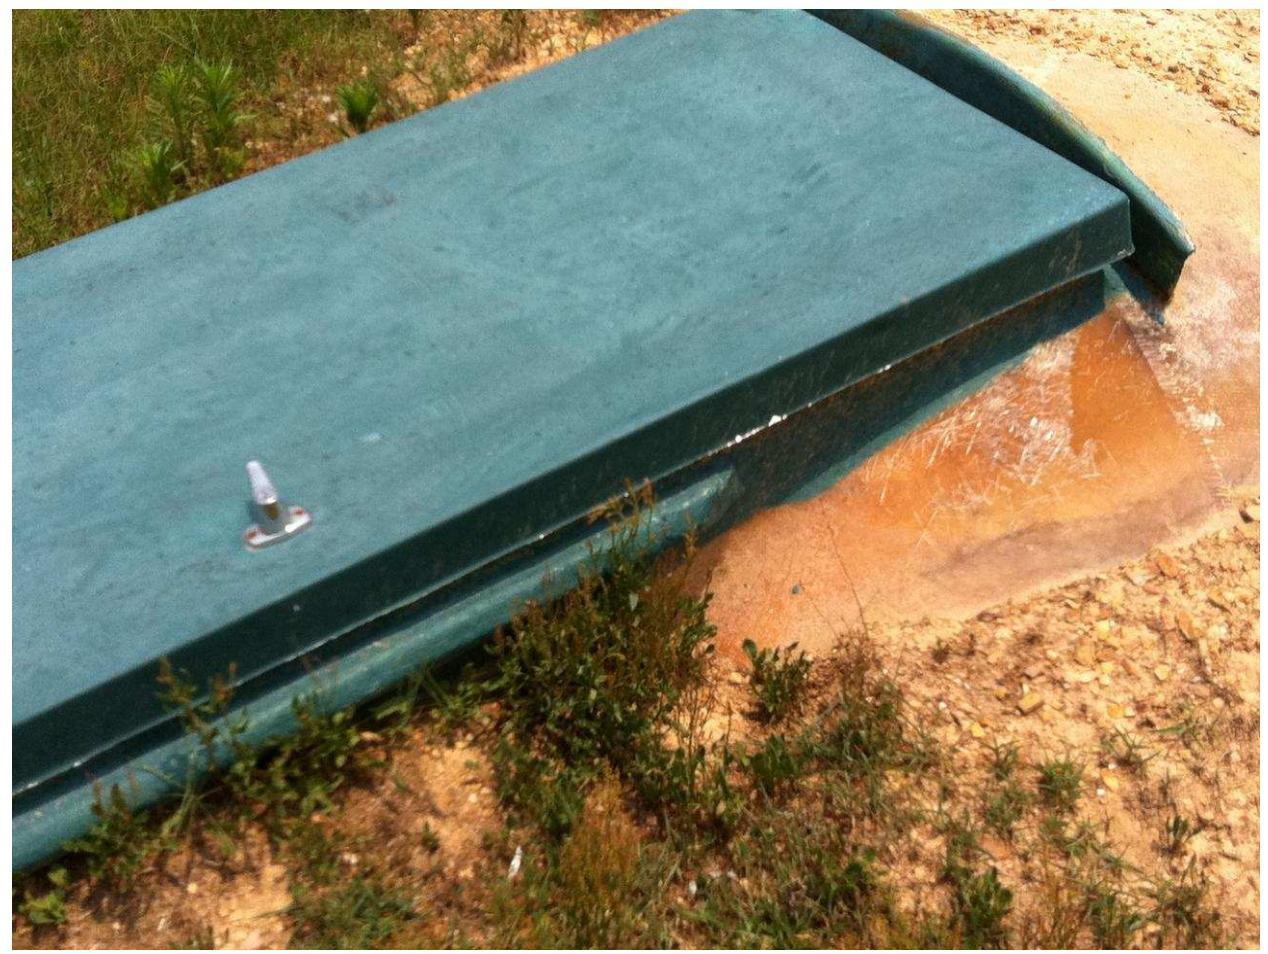
Fig. 12. Near Rainsville, AL, the final EF5 tornado of the outbreak swept homes away, and scoured much of the overlying dirt from the top of a buried storm shelter; the occupants cowered inside, as the shelter shook and almost heaved up out of the soil.

The same supercell that resulted from the merger of a new supercell with the Neshoba County, MS, EF5 storm, spawned a new EF5 tornado in DeKalb County, AL. Just east of Rainsville, AL, the tornado reached peak intensity. It swept away several well-built homes, ripping an 800-lb safe from its concrete slab anchorage and tossing it more than 600 ft into nearby woods. The couple in the home survived by seeking shelter in an underground storm pit, which had part of its soil cover stripped away by the tornado, causing the storm pit to become unstable and heave slightly upwards (Fig. 12). At another residence, destruction of the house was accompanied by collapse of a concrete porch column, which resulted in the leveraging up out of the ground of the supporting concrete porch and foundation (Fig. 13). This tornado also stripped pavement off of several roads. After crossing into Georgia, the tornado dissipated, but was quickly followed by another EF4 violent tornado near Ringgold, GA. The parent supercell storm lasted at least 13.1 h, finally weakening and merging with other convection near Front Royal, VA.

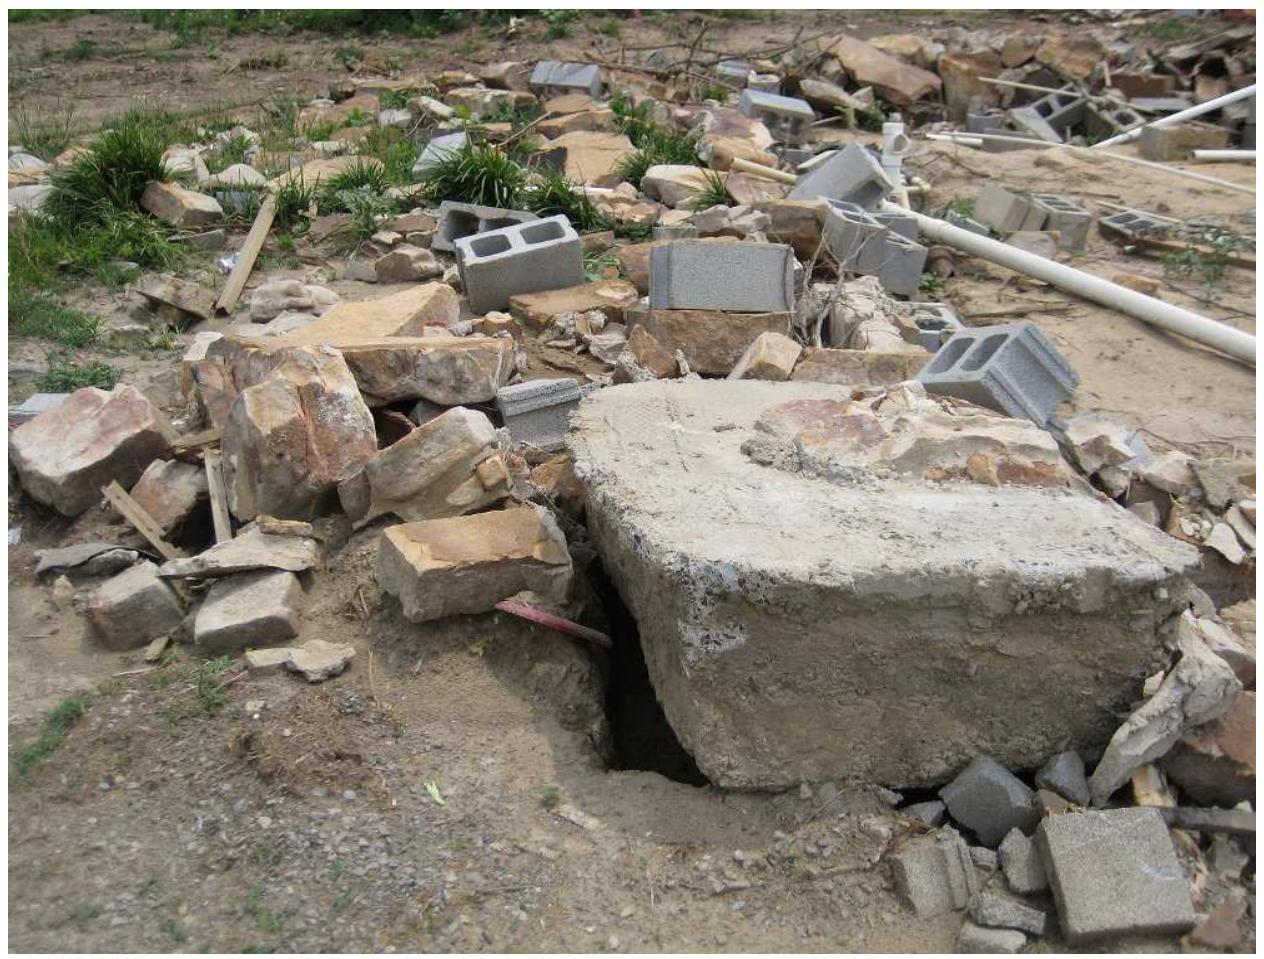
Fig. 13. East of Rainsville, the EF5 tornado demolished old stone and concrete houses, toppling concrete columns, and leveraging one structure's concrete foundation up out of the ground. Some 25 persons were killed by this tornado.
