Timothy P. Marshall\* William F. Bunting Haag Engineering Co. NWS/NOAA/FTW

# **1. INTRODUCTION**

The authors have developed a procedure for assessing wind damage to wood-framed residences. This procedure has been utilized by the authors for the past twenty years when determining the extent of damage to buildings from tornadoes, hurricanes, and straight-lined winds. In order to develop the procedure, the authors have compiled information on various building construction techniques as well as analyzed how wind forces interact with buildings and their environments. There are a number of helpful references on the subject including papers by Minor et al. (1977) and Bunting and Smith (1990). Many myths associated with wind effects on buildings have been discussed by Minor (1976, 1982) and Marshall (1992).

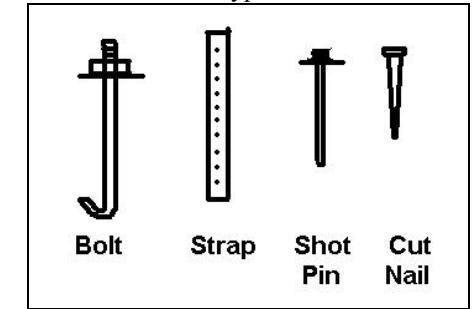
Figure 1. Common types of foundation fasteners.

Homes on concrete slab foundations usually are bolted or strapped to their foundations. However, some municipalities have adopted variances in the building codes that allow shot pins or cut nails. Figure 1 shows common types of foundation anchors.

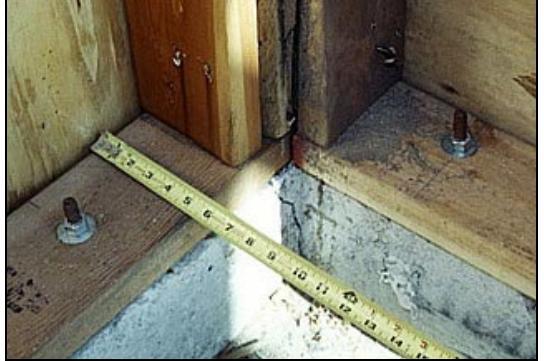
**Figure 2.** Properly bolted bottom plate. However, note the weak straight-nailed connection between the wall studs and bottom plates.

Anchor bolts are at least 1.3 cm (1/2 inch) in diameter and 30 cm (12 inches) long and have a J-shaped profile that provides significant pull-out resistance. The anchor bolt is inserted into the concrete slab while it is poured with a depth of at least seven inches and must have sufficient height above the slab to pass through the plate and accept a steel nut and washer. Anchor bolts are spaced 1 to 2 meters (3 to 6 feet) apart and located within 30 cm (12 inches) of the end of the plate and wall corners (Figure 2).

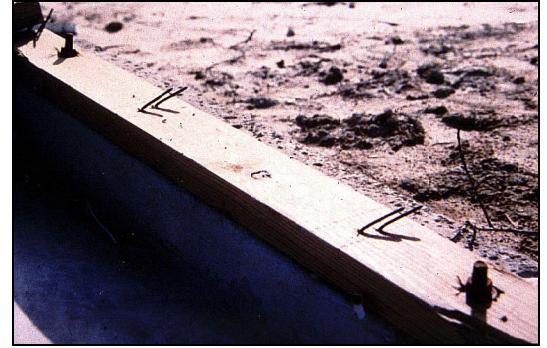
**Figure 3.** Failure of this home occurred where the wall stud was nailed to the bottom plate.

Anchor bolts must be inserted properly into the concrete slab foundation. We have found anchor bolts placed too deep in the concrete to engage the nuts. We also have found bolts placed outside or inside of the wooden sills or bottom plates. Thus, these homes were not anchored to their foundations. Also, nuts and washers must be fitted on the anchor bolts and tightened snug to secure the plates. This might seem obvious, however, we have found numerous bolted plates and sills without nuts or washers. A properly anchored sill or bottom plate is a strong connection and rarely fails. Instead, failure of the home is more likely where the wall stud is nailed to the bottom plate (Figure 3). Therefore, homes that are bolted down to their foundations are not necessarily well-built or wind resistant.

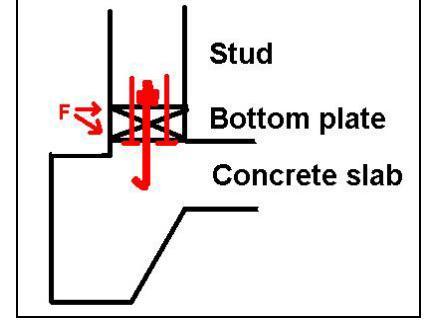
**Figure 4**. Typical wall cross section on concrete slab foundation showing a bottom plate bolted to the foundation and straight-nailed into the wall stud. Connections and failure points ("F") are in red.

The bottom plate is either straight-nailed into the wall stud and/or the wall stud is toenailed into the bottom plate (Figure 4). A pair of 16d (8.9 cm or 3.5 in) common nails often are used for this connection. Although such a connection will meet the minimum requirements in most building codes, it is inherently weak when uplifted (Figure 4).

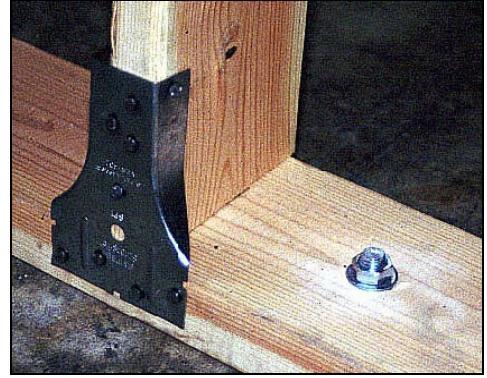
**Figure 5.** A metal clip connecting the wall stud to the bottom plate provides considerably more uplift resistance than conventional straight- or toe- nailing.

Marshall (1983) conducted pull tests on pairs of 16d nails that connected plates to studs. For straightnailed connections, the average pull-out strength was 984 N (220 lbs.) with a standard deviation of 375 N (84 lbs). For toenailed connections, the average pullout strength was 1313 N (295 lbs) with a standard deviation of 304 N (68 lbs). Canfield et al. (1991) conducted similar pull tests with similar results. However, they could increase the average pull-out strength to 1842 N (414 lbs) if the wood did not split when nailed. By comparison, Canfield et al. (1991) also conducted pull tests on metal "hurricane" clips and found an average strength of 5341 N (1200 lbs) depending on the type of clip used. Thus, a metal clip can be about three times stronger than a 16d (8.9 cm or 3.5 in) toenailed connection (Figure 5).

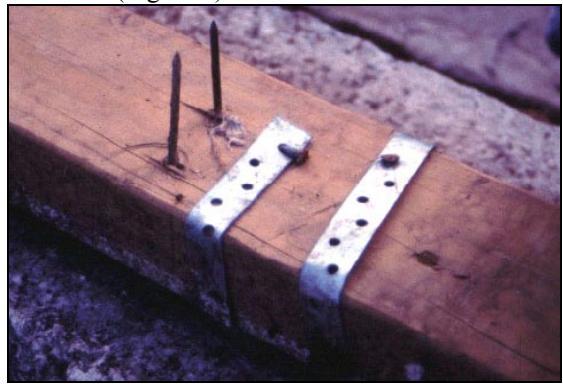
**Figure 6.** Metal straps held the bottom plate in place, however, failure occurred where the wall stud was straight-nailed through the bottom plate.

Besides anchor bolts, bottom plates are attached to the concrete slab with metal straps, shot pins, or cut nails. Metal straps can be just as effective as bolts in anchoring the bottom plate to the foundation if they have proper thickness and are installed correctly (Figure 6). The straps are typically made from 18 gauge metal (1.2 mm or .0478 inches) and are perforated for the fasteners. Steel shot pins look like thick nails and literally are shot into the foundation with a powder actuated hammer. Shot pins are typically 7.6 cm (3 inches) long and have an accompanying washer (Figure 7). Unfortunately, cut nails sometimes are used to secure the bottom plates to the foundations. Cut nails are easily pulled through the bottom plate when the plate is uplifted or rotated. Building codes do not allow the use of cut nails, however, some building officials have allowed cut nails to secure interior (not perimeter) walls. Unfortunately, we have found many homes where cut nails were installed around the perimeter of the foundation (Figure 8)

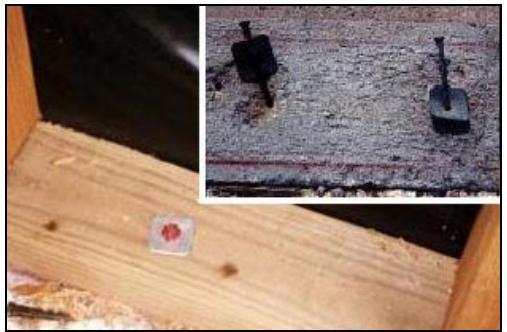
**Figure 7.** Shot pin with attached washer in the bottom plate. Inset photo shows aftermath of tornado where bottom plate broke around the fasteners.

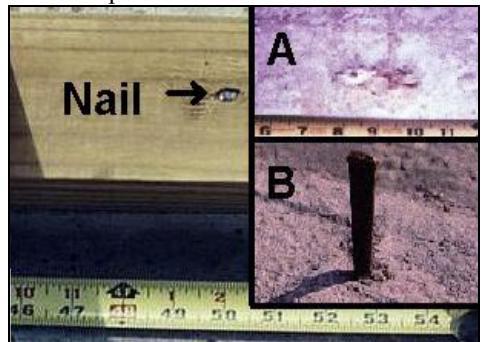
**Figure 8.** Cut nail in the perimeter bottom plate was a violation of the local building code. Inset photograph A shows scrape mark in the slab after wall slid off foundation. Inset photograph B is a cut nail left in the foundation after home was blown away.

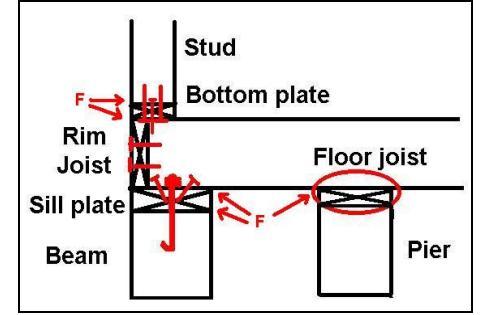
Figure 9. Typical pier and beam foundation showing connections and failure points (in red). However, piers are rarely attached to the flooring (circled).

Pier and beam foundations usually are made of different materials. Piers can be wood, loose block, masonry, or concrete. Perimeter grade beams are usually poured-in-place concrete or masonry. The same types of anchors are used to secure the house to the beams as with concrete slab foundations. However, floors are supported by the piers and rarely anchored (Figure 9). Note the floor platform separates the walls from the foundation, resulting in

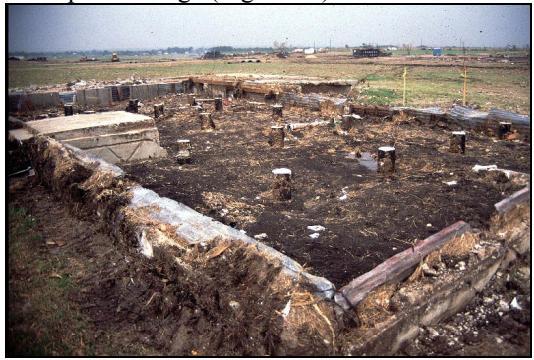
**Figure 10.** This home shifted and disintegrated from its wooden pier and concrete beam foundation. Floor joists were not attached to the piers.

more nailed connections. In general, the more nailed connections in a foundation, the greater the chances for a poor connection. The authors have identified failures at each of the nailed location points in this type of foundation. Usually, the anchor bolted sill plate remains. Homes on pier and beam foundations tend to shift off their foundations and sustain more catastrophic damage (Figure 10).

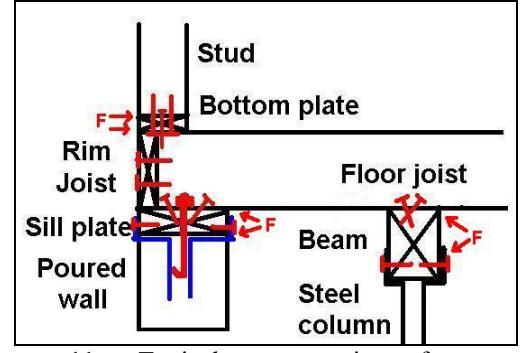
**Figure 11.** Typical cross section of a poured concrete wall foundation showing nailed and bolted connections with failure points (in red) and strapped connections (in blue). Center beam is wood or steel.

Poured concrete wall foundations are found in homes that have basements or crawl spaces. A concrete footing supports the foundation wall. The wooden sill plate is either bolted or strapped around the perimeter of the foundation. Floor joists typically are toenailed to the sill plate. A center beam extends across the middle of the basement or crawl space and is supported by columns and slotted into the perimeter wall. The center beam and columns are either wood or steel (Figure 11).

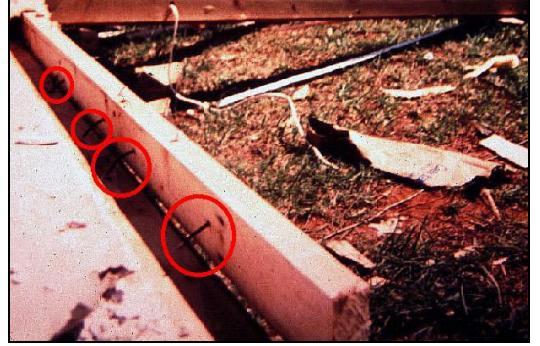
**Figure 12.** Straight-nailed bottom plate pulled out of the floor as the wall rotated. This was an inherently weak connection (circled).

A common failure point is where the bottom plate is secured to the floor. The bottom plate is straight nailed to the floor at certain intervals and the nails usually miss the underlying floor joists. Thus, this connection has little resistance to lateral wind loads and the connection simply pulls apart as the wall is rotated (Figure 12). In many instances, the authors have found nails driven into the open joint between the rim joist and the floor joist leaving the wall virtually unattached. The floor platform usually remains if properly anchored to the foundation.

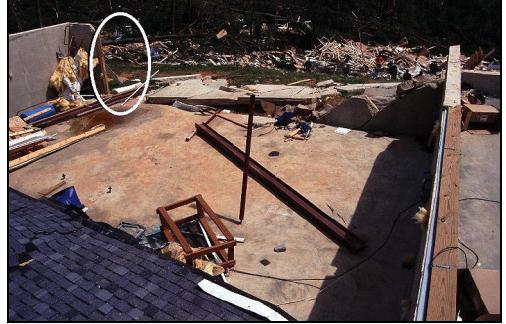
**Figure 13.** Exit door weakened the concrete wall foundation (circled). The foundation wall rotated and broke apart at the opposite corner. Steel rebar was used only at the wall corners. The house was pushed into the ravine in the background.

A more catastrophic failure occurs when the connection between the floor joists and sill plate fails. This results in the entire home sliding off its foundation. The authors also have found no attachment of the center beam to the floor joists especially if the center beam was steel. Also, doors and windows in the foundation wall can weaken its lateral resistance leading to overturning of the foundation wall (Figure 13).

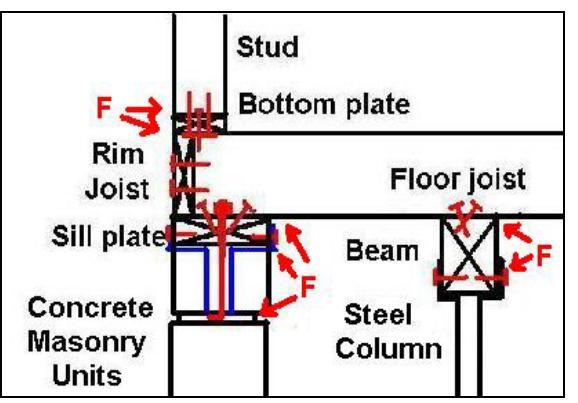
**Figure 14.** Typical cross section of a masonry wall foundation showing nailed and bolted connections (in red) and strapped connections (in blue). Center beam is wood or steel. Failure of this foundation type frequently occurs at areas denoted by the letter "F".

Masonry wall foundations are constructed with concrete masonry units (CMU). These units have open cells that are stacked in a common pattern with mortared joints. The connection of the house to the foundation is similar to that of concrete foundation walls. However, the top cell is usually filled with mortar or concrete where the anchor bolts or straps are placed (Figure 14).

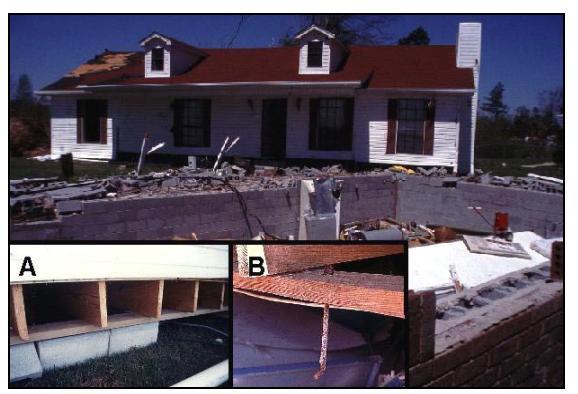
**Figure 15.** This home shifted off its foundation when the masonry foundation failed. Inset photograph A shows that the top row of masonry was attached with J-bolts as shown in inset photograph B. Note how little damage there was to the roof.

Unreinforced concrete masonry foundations are inherently weak in resisting lateral and uplift forces and frequently fail causing the house to slide along with the top row of concrete masonry (Refer to Figure 15). Interestingly, building codes in high wind areas require steel reinforcement to extend through the cells all the way down into the footing.

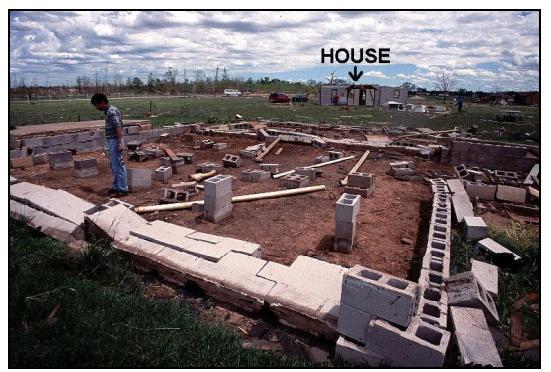
**Figure 16.** Unanchored home on stacked CMU foundation slid 90m (295 ft) off its foundation.

Homes constructed on loosely stacked brick or block foundations are not anchored and can be easily shifted from their foundations (Figure 16). Such homes can be "swept clean" from their foundations resulting in F-5 damage on the Fujita scale with wind speeds less than 45 m/s (100 mph).

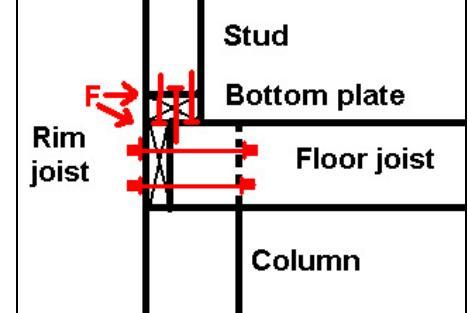
**Figure 17.** Typical cross section of home elevated on timber piles, concrete or masonry columns. Floors are usually bolted or strapped to the columns (in red). Common failure points are the nailed connections where the wall is attached to the floor.

Homes elevated on timber pilings, or concrete or masonry columns usually have substantial anchoring of the floor system. Weak points in this type of construction are where the bottom plates are nailed to the floors or where the wall studs are nailed to the bottom plates. Use of hurricane clips or straps can provide a much stronger connection provided they are installed properly and are protected from corrosion due to salt exposure. Wind damage to these homes usually involves loss of the walls leaving the floor intact (Figures 17 and 18).

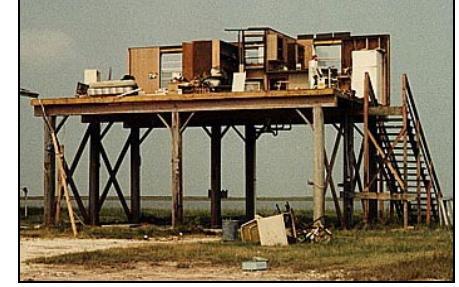
**Figure 18.** Wind damage to a home elevated on timber piles. Failure commonly occurs where the walls are attached to the floor.

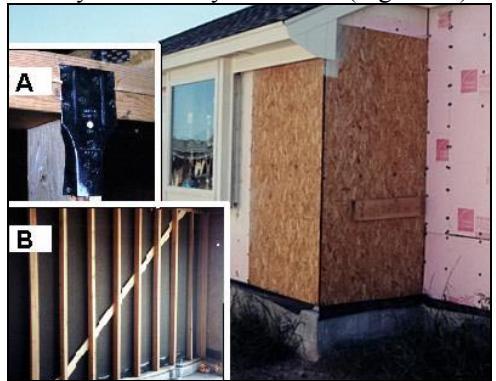
**Figure 19.** Installation of solid sheathing at wall corners helps stiffen the frame. Top plate clips as shown in inset photograph A and diagonal bracing as shown in inset photograph B also stiffen the frame.

Wood-framed walls need to be braced properly to stiffen the frame and resist racking from lateral loads. At a minimum, diagonal bracing or "let-ins" are required at all wall corners. Typically, wall studs are notched to receive a wooden board that extends diagonally from the top plate at the wall corner to the bottom plate and is nailed to the studs. Plywood or oriented strand board (OSB) is some times utilized at the wall corners, especially when diagonal bracing cannot be installed due to an intervening window or door (Figure 19).

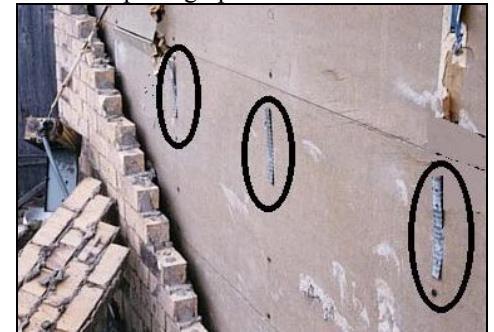
**Figure 20.** Brick ties (circled) were installed on this home but not engaged into the mortar joints. As a result, wind easily toppled this unanchored wall.

Loss of brick veneer is a common problem due to improper attachment of the masonry to the woodframed wall. Corrugated brick ties or wires must be imbedded at least two inches into the mortar joints and attached properly to the wall. Walls that are not attached properly are free-standing and can be moved even by applying hand pressure. Such walls can topple easily in relatively low winds (Figure 20).

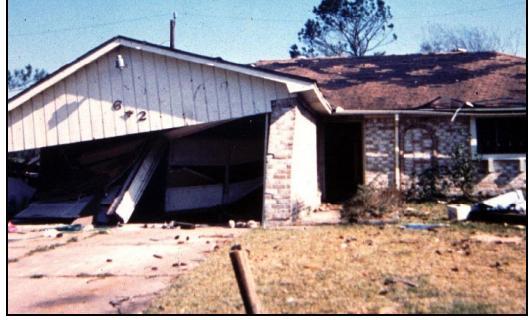
Figure 21. Inward failure of garage door led to outward failure of sidewall and collapse of the garage. Note little damage to remainder of home.

Weak links in wall systems are large windows or doors that interrupt the continuity of the framing. In addition, failure of windows and doors allows wind to enter the building increasing internal pressures that can help lift the roof and push out perimeter walls. Garage doors are inherently weak and often fail in wind speeds as low as 36 m/s (80 mph). The doors buckle or pop off the door tracks allowing the wind to enter the garage (Figure 21).

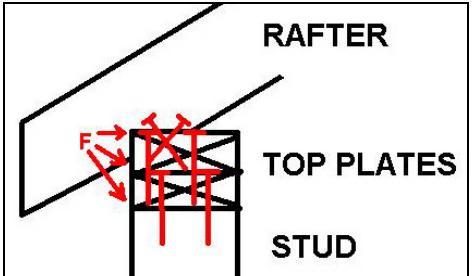
**Figure 22.** Typical cross section of roof/wall top plate showing nailed connections and common failure points (in red).

Roof systems typically are held in place by gravity. Thus, minimal attention is given to wind uplift effects. Typically, the rafters or trusses are toenailed to the wall top plates and this type of connection will meet most building codes (Figure 22). However, this connection is inherently weak when uplifted. Rafters or trusses will break away from the top plates. It is less common for the top plates to separate. Metal straps or clips can secure all of these members together.

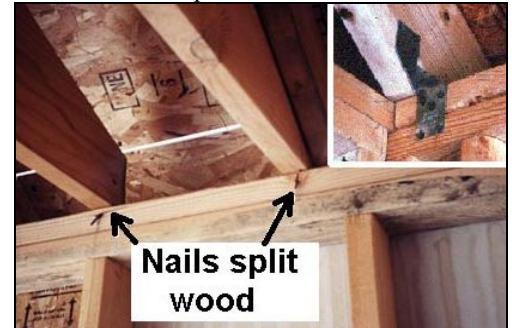
Figure 23. Nails driven through rafters and ceiling joists protruded through the top plate and split the wood. A better connection would have been to install metal clips as shown in the inset photograph that places the nails in shear (strong) instead of tension (weak).

The authors have found numerous examples where rafters and trusses were not fastened adequately to the wall top plates. Nails had split the wood or were driven through knots or other defects in the wood (Figure 23). As a result, the entire roof was susceptible to being removed in relatively low wind speeds. Properly installed hurricane clips or metal straps can strengthen this connection greatly. A house that is missing its roof usually had poor attachments at the tops of the walls.

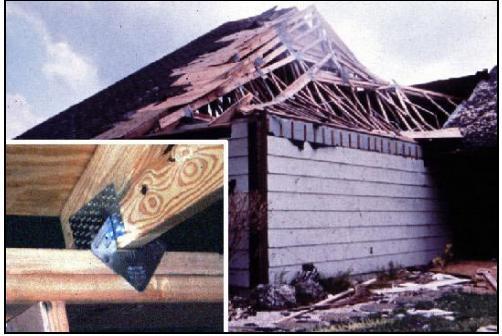
**Figure 24.** Toppled roof trusses due to a lack of lateral bracing. A metal bracket (inset photograph) along with proper wooden blocking between the trusses would have prevented rotation of the trusses.

Rafters and trusses require proper cross bracing to resist lateral wind forces. Installation of ridge blocking and metal brackets can prevent the trusses from falling down like dominoes. Although gable ends are non-structural components, they are susceptible to being blown inward or outward depending on the wind direction (Figure 24).

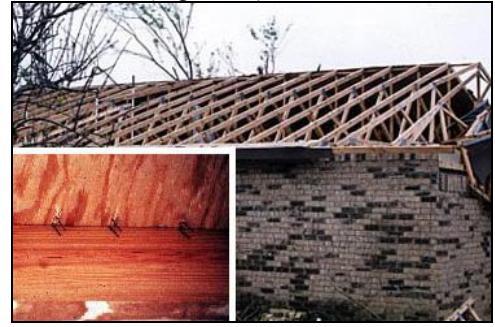
**Figure 25** House that lost all of its roof decking on the leeward slope. Close inspection revealed that staples missed the underlying rafters (inset photograph).

Roof decking is typically plywood, oriented strand board (OSB), or wooden boards. The decking is fastened at six-inch intervals and fasteners must penetrate into the underlying rafters or trusses. Commonly, pneumatic guns are used to drive fasteners into the decking and in some instances, the fasteners miss the underlying framing. As a result, the roof deck is not attached and is quite susceptible to being removed in the wind. The authors have found entire sheets of plywood fully clad with roof shingles in the debris around the home. Exposure of the rafters and trusses usually indicates inadequate deck attachment (Figure 25).

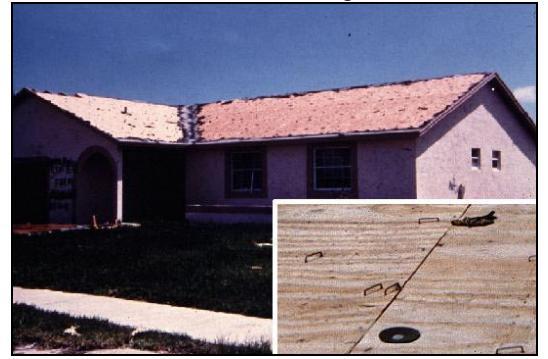
**Figure 26.** Poor installation of the roof covering on this home led to its complete removal. Staples were installed crooked and under-driven(inset photograph).

There are many different types of roofing materials on residences including asphalt shingles, tile, metal, wood shingles, shakes, etc. Each industry has guidelines available for proper installation of the roofing product. Installation instructions usually are printed on labels accompanying the roofing product indicating the proper size, number and spacing of Roof coverings also must meet the fasteners. minimum wind uplift requirements as stated in the building codes. However, the authors have found numerous deficiencies with installations of roof coverings that have led to their removal in relatively low wind speeds (Figure 26). Common roof installation errors include placing fasteners too high on the product, overdriving, under-driving, or orienting the fasteners incorrectly. Tile roofs secured with mortar tend to unbond leading to tile removal.
